CAIRNGORM FUNICULAR RAILWAY

VIADUCT STRENGTHENING REPORT

PROJECT NO. A116993
DOCUMENT NO. Rp03

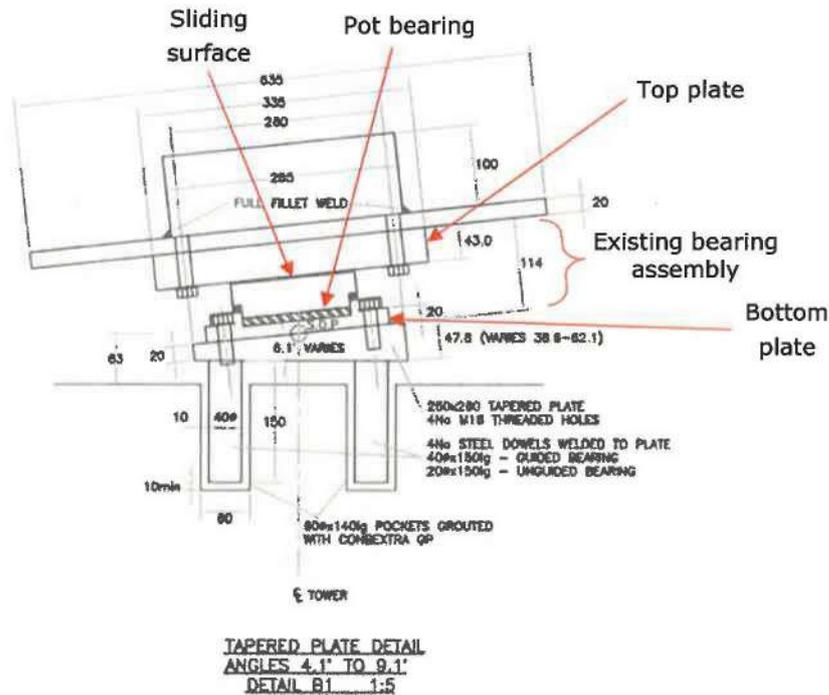
The tapered plates / steel shoes are supported on grout pads. The thickness of the grout pads varies to accommodate construction tolerances but are generally around 50 mm.

Figure 1 Current bearing detail at piers with tapered plates (tapered plates used at 62 No. locations)

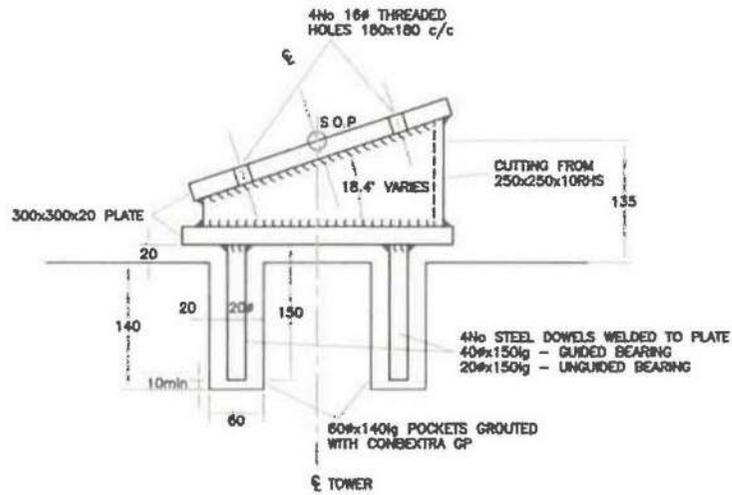
Figure 2 Steel shoe detail (134 No. locations). Bearing detail otherwise the same as with tapered plates.

(Note that keeping the steel shoes assumes that they are in adequate condition. Possible observations of cracks in the shoes by ADAC Structures Ltd. may further investigation and necessitate replacement of the shoes. Replacement of the shoes would either require destructive works in the crosshead beams or site fabrication works to replace the existing hollow sections.)

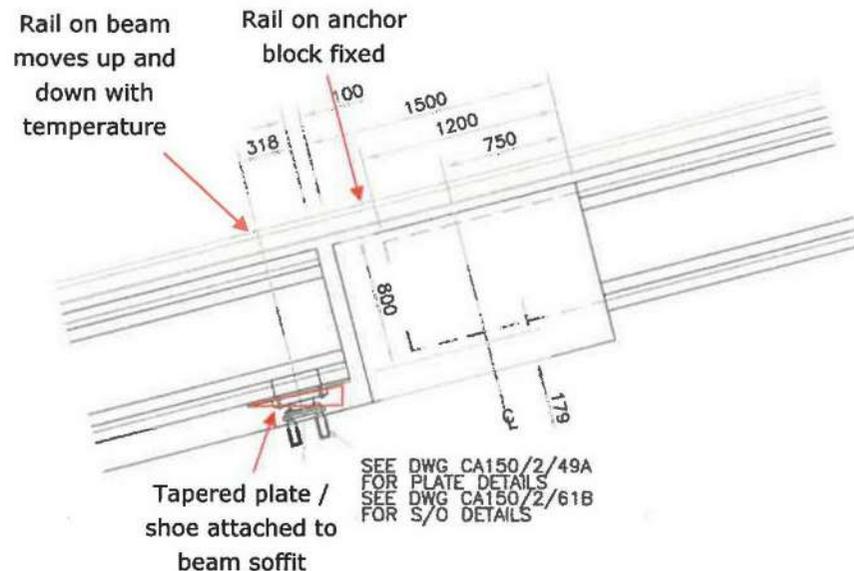
- > Change in the rail level above the bearings would occur due to thermal expansion / contraction. At the anchor block bearings, this could create a prohibitive change in rail level across the movement joints (see Figure 11). A way of preventing this effect is discussed in the following Section 2.2.1.

Figure 11 Effect of flat bearing on rail level at movement joints

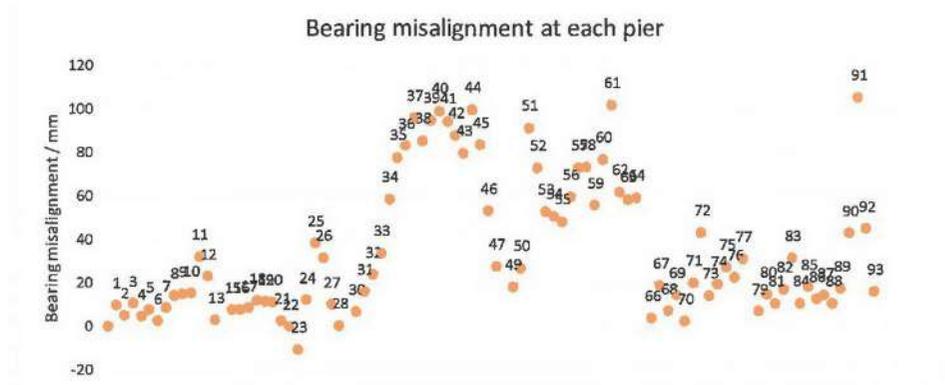
Observations of the bearings by COWI and ADAC Structures Ltd. have noted that the bearings are misaligned to original design intent (see Section 2.3). As the bearings approach their assumed design life of circa 20yrs the PTFE sliding surfaces are exhibiting significant wear. The bearings have also been calculated to be ~50% overstressed due to SLS loading at the operational wind case, using BS 5400-9.1 criteria. Bearing replacement is therefore deemed necessary, with the new bearings being modified to prevent overstress from occurring.

Figure 12 Theoretical bearing misalignment at 5°C

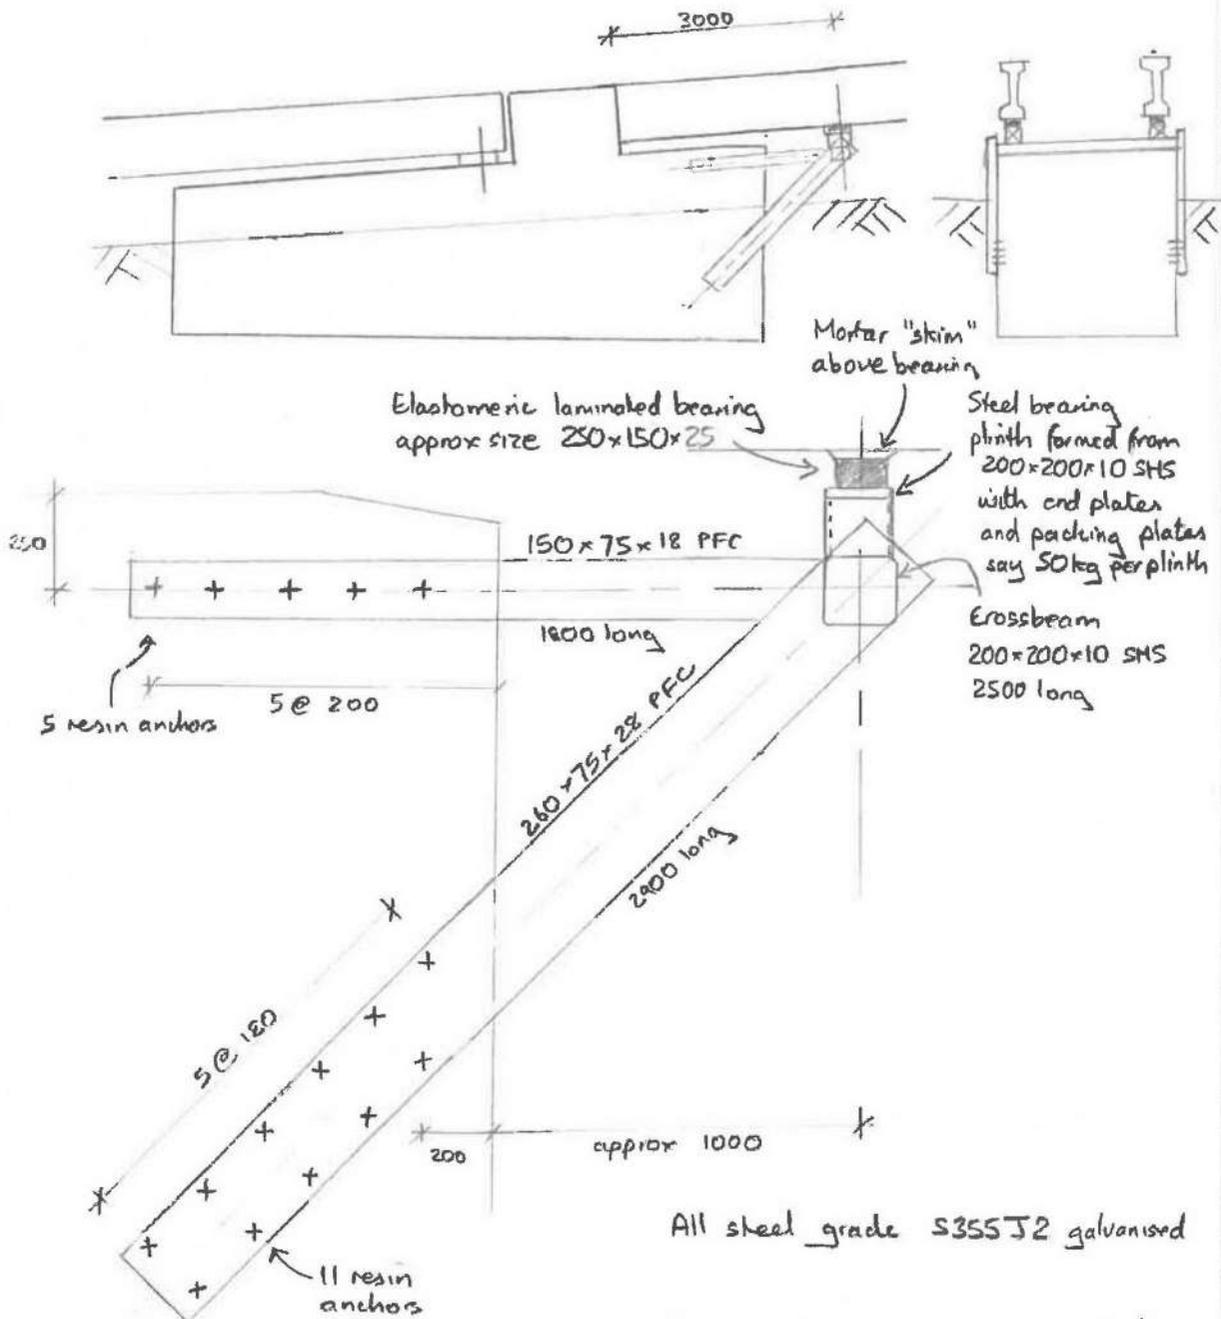
Anchor blocks 14 & 29

Steel frame supports bearing, since bearing would otherwise be off the anchor block

All steel grade S355J2 galvanised

Resin anchors M20 stainless steel with minimum 150 embedment into concrete

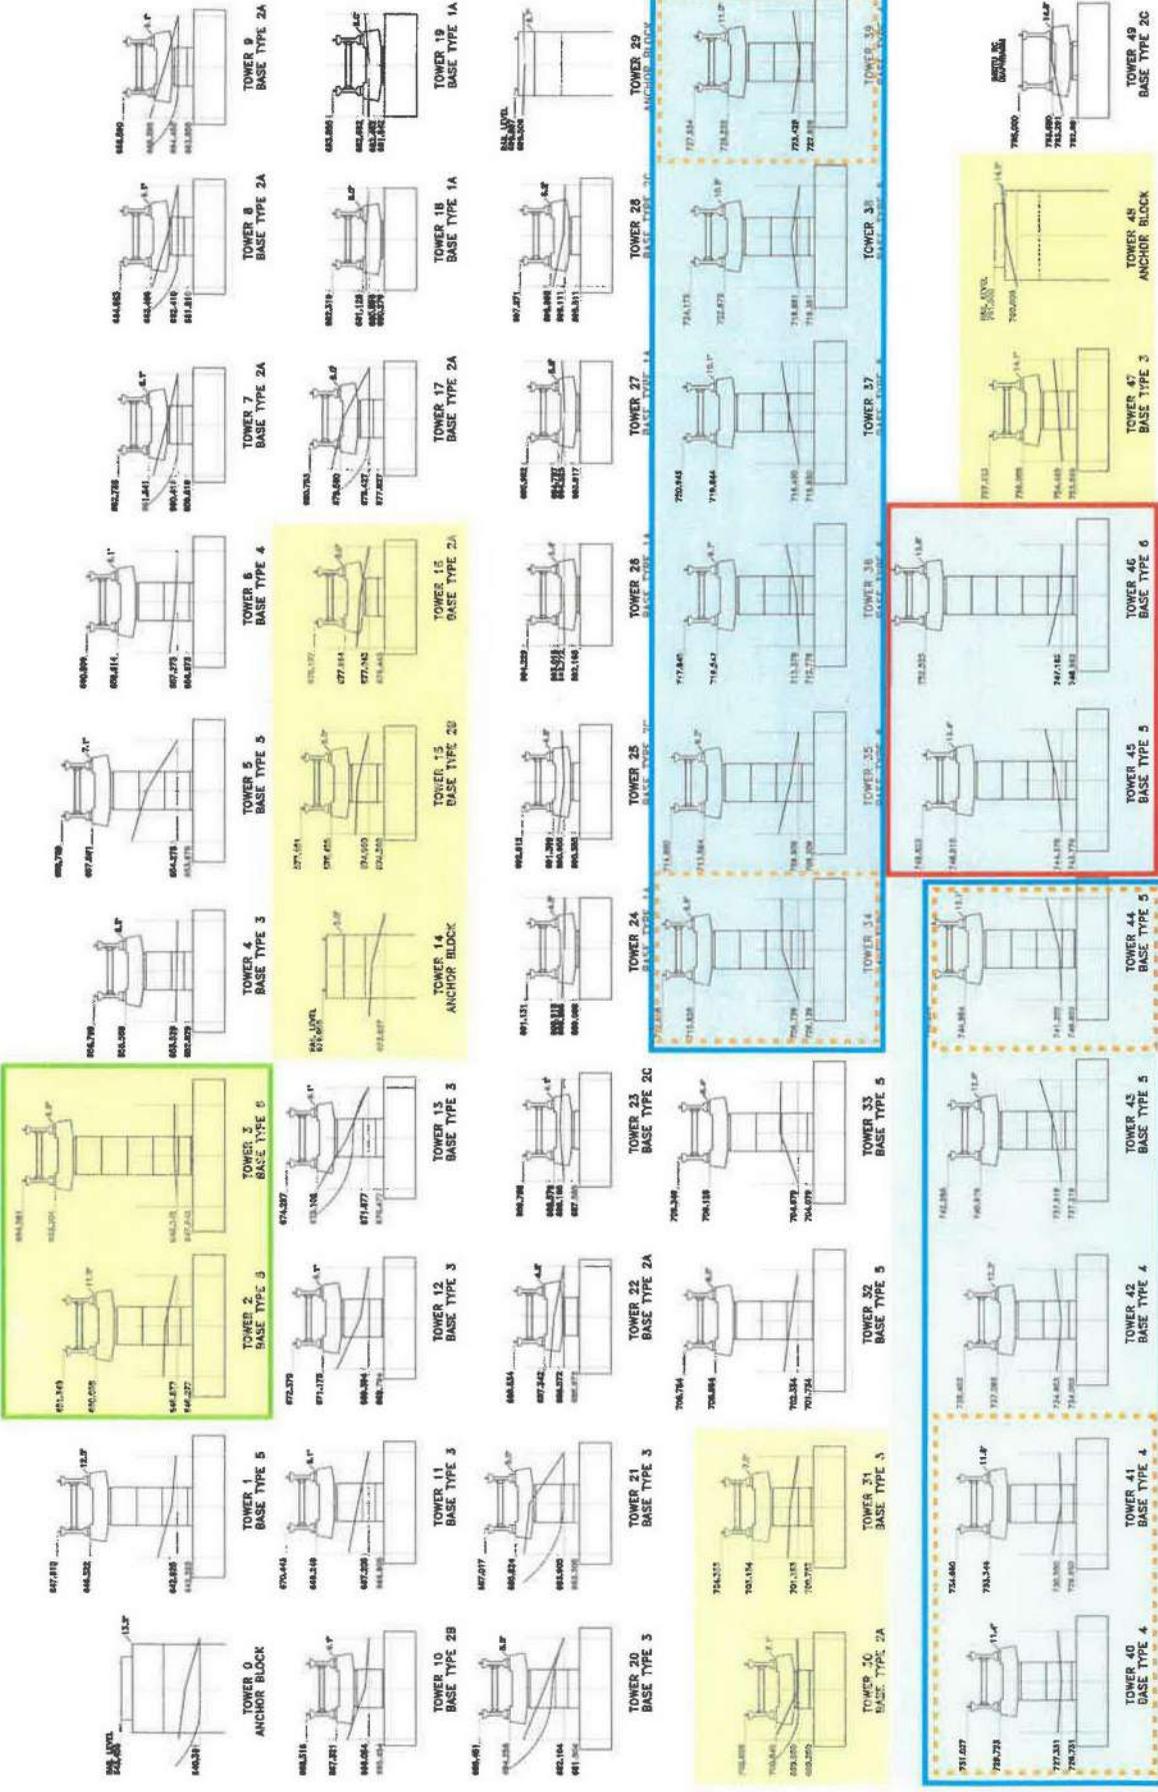
Key:
 BLUE SHADING - PIERS WITH BEARINGS MISALIGNED >50mm
 PURPLE SHADING - PIER CROSSHEAD OVERLOADED
 YELLOW SHADING - ADJACENT TO ACCESS ROAD

PURPLE OUTLINE - REQUIRES STRENGTHENING TO SUPPORT CROSSHEAD
 RED OUTLINE - REQUIRES STRENGTHENING DUE TO PIER UTILISATION >1.00
 ORANGE OUTLINE - STRENGTHENING RECOMMENDED SINCE PIER UTILISATION VERY HIGH
 BLUE OUTLINE - STRENGTHENING RECOMMENDED SINCE BEARINGS MISALIGNED AND PIER UTILISATION HIGH
 GREEN OUTLINE - STRENGTHENING RECOMMENDED TO GIVE RESILIENCE TO COLLISION LOAD
