PLANNED MAINTENANCE CONDITION SURVEY REPORT

**BUILDING CODE:
WASTE WATER TREATMENT PLANT (BOTTOM
CAR PARK) CAIRNGORM MOUNTAIN
CAIRNGORM**

HIGHLANDS AND ISLANDS ENTERPRISE

MARCH 2011

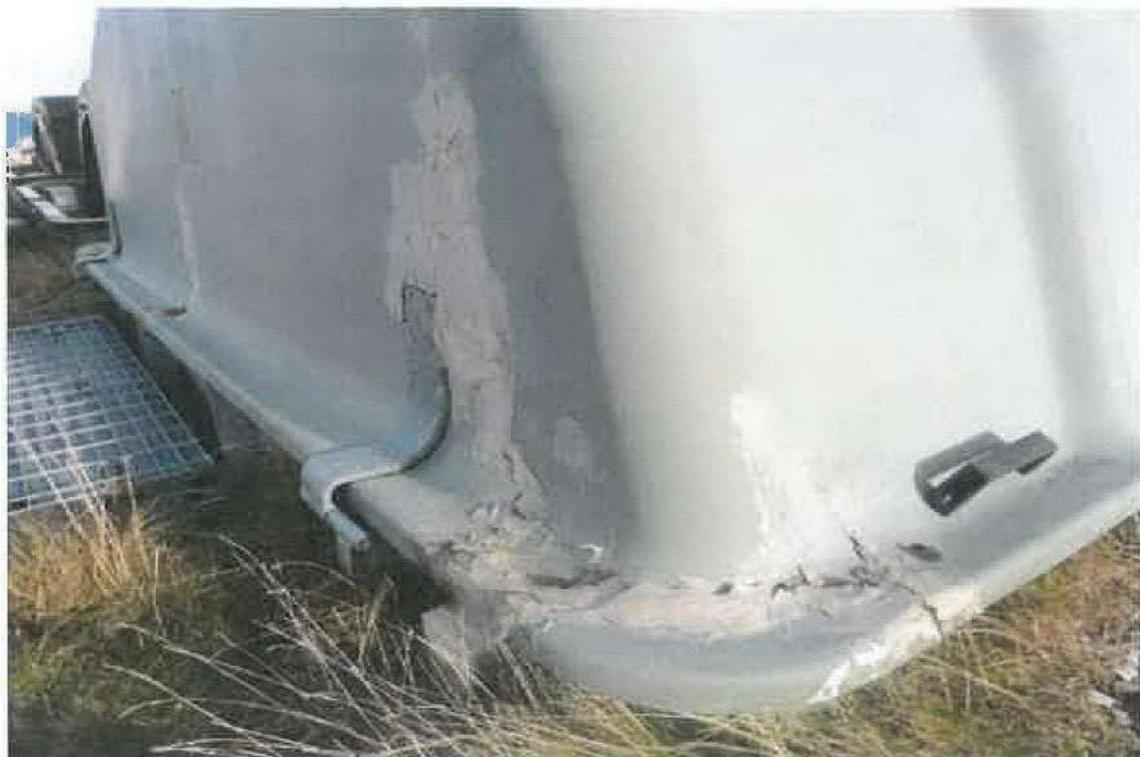
RBC corner damaged
