**PLANNED MAINTENANCE CONDITION  
SURVEY REPORT**

**SHEILING BUILDING, CAIRNGORM MOUNTAIN, CAIRNGORM**

**COIRE NA CISTE BUILDING, CAIRNGORM MOUNTAIN, CAIRNGORM**

**KASSBOHRER WORKSHOP, CAIRNGORM MOUNTAIN, CAIRNGORM**

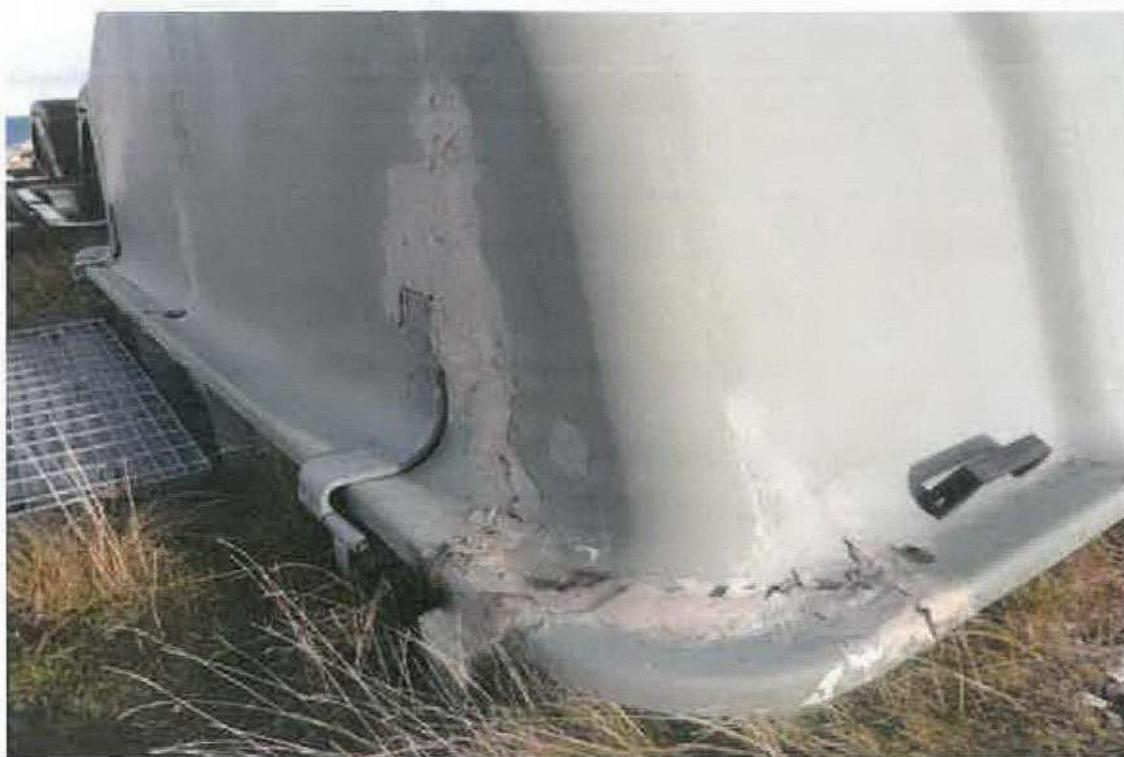
RBC corner damaged
