## Cairngorm Ski Towers Inspection Report

for Highlands & Islands

Job Ref: SJ1021

August 2014

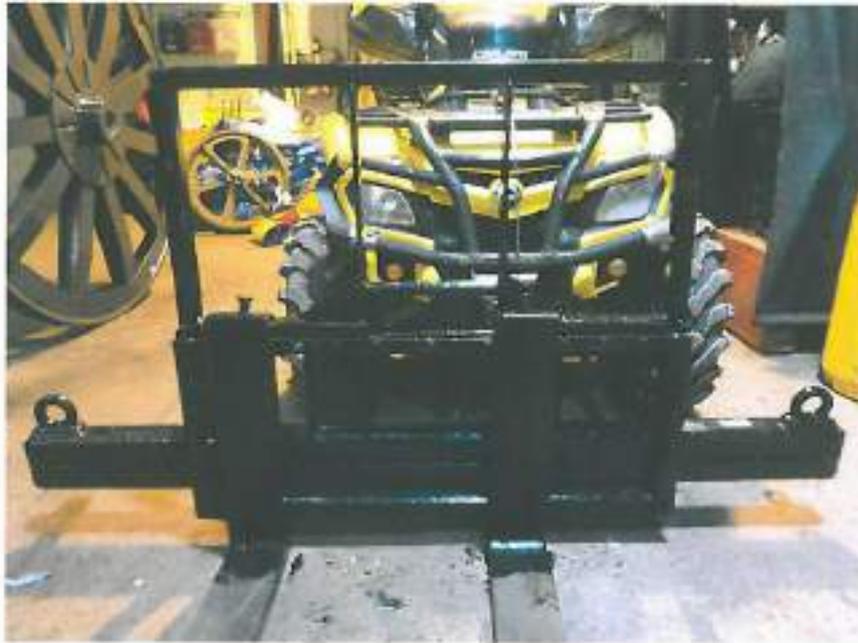
The fork lift forks were found to be in good condition with no surface breaking defects noted during the Magnetic Particle inspection. There were various defects noted on the ski towers. All findings from the inspections are recorded on the relevant reports.

Standoff photo of forklift forks inspected

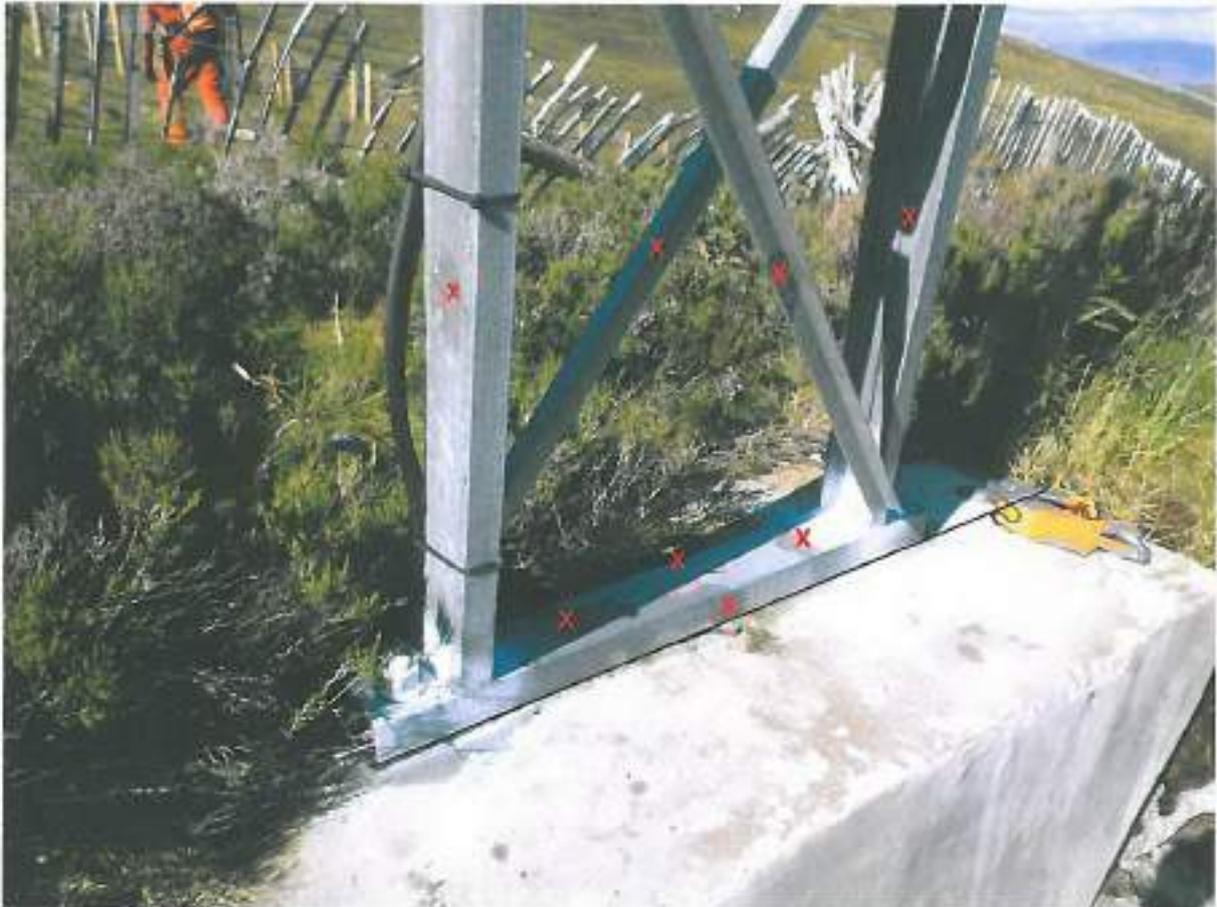
X Marks spot checked areas

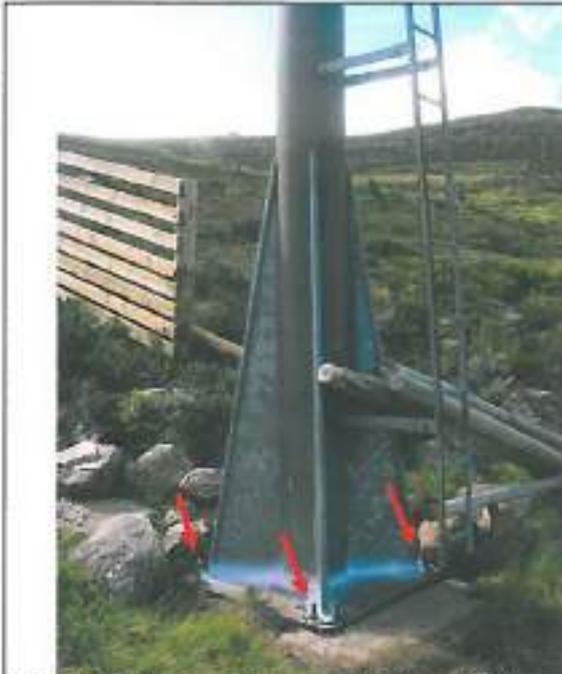
Stand-off Photographic record of Base Plate and Stiffeners on Tower 2. Red Arrows indicate Anchor Bolts and washers impeding inspection of Stiffener Foot Weld and HAZ.

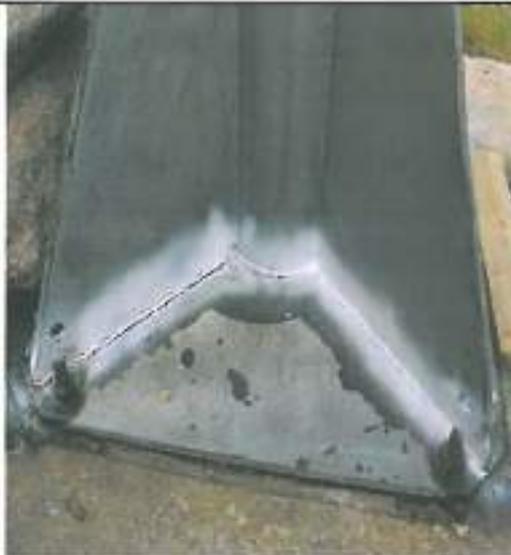
Stand-off Photographic record of Base Plate and Anchor Bolts on Tower 2. No Restrictions encountered. A 7mm Indication was found on the right hand side Stiffener facing down-hill.

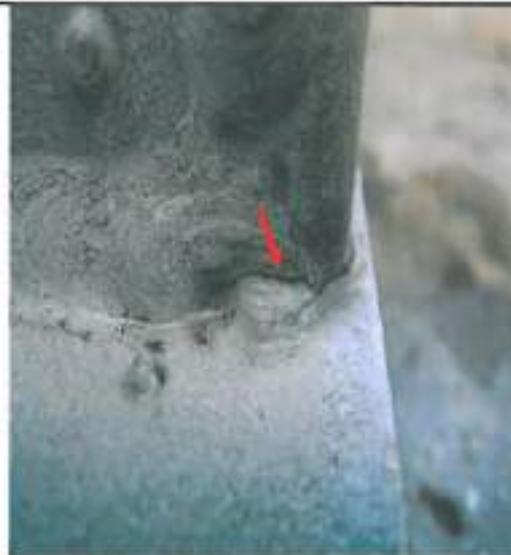
Tow 5 – TC Porosity found in base weld  
TE Porosity found in base weld  
T2 7mm defect found in base weld

Photographic record showing 7mm Indication on right hand side Stiffener facing down-hill on Tower 2 indicated by red arrow.

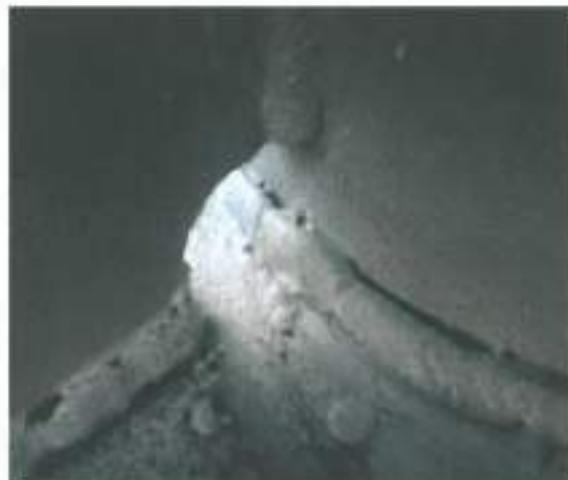
Photographic record showing Porosity on Tower Deck Connection weld and Stiffener Deck connection weld on left hand side down-hill Stiffener on Tower C. Porosity found Throughout Deck Connection welds on Tower C.

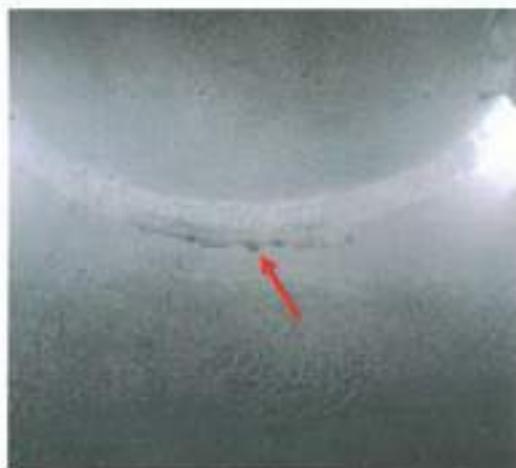
Tower E: No restrictions encountered. Undercutting was found on Tower to Deck Connection weld on Tower E facing down-hill. Porosity was also found on Stiffener Deck Connection weld on Right hand side Stiffener facing down-hill.

Photographic record showing undercut on Tower to Deck Connection weld on Tower E down-hill facing.

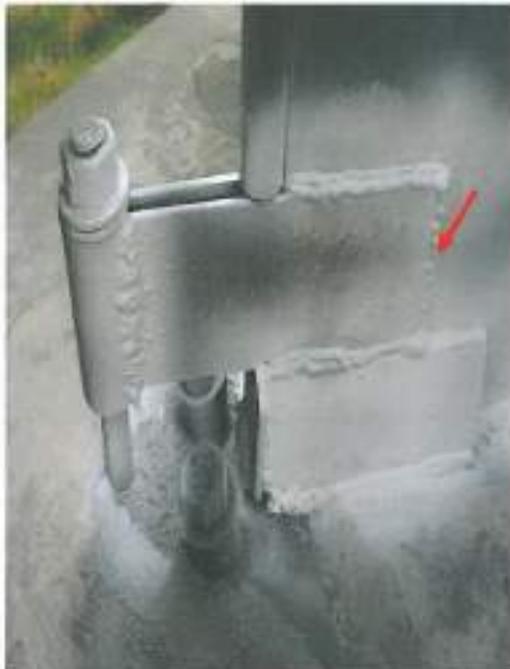
Photographic record of Base Plate Connection weld to Stiffener web configuration on Tower 2. Porosity Found throughout Anchor Bolt Housing to Web welds.

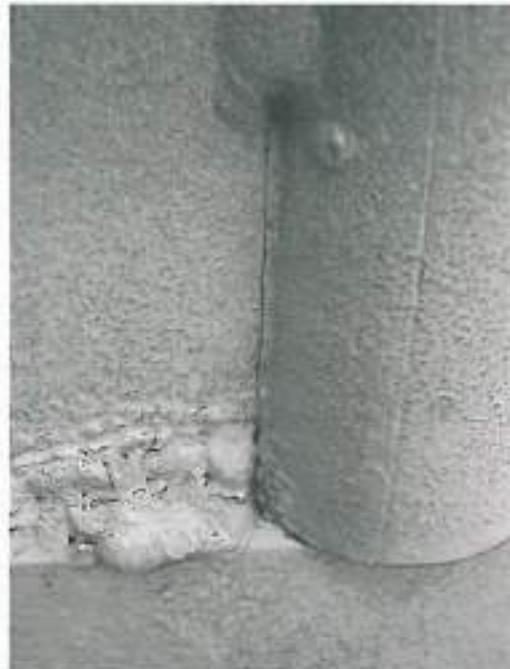
Tow 8 – T2 Porosity found in base weld and a 55mm non structural defect found

Photographic record showing 55mm indication on Base Plate Stiffener Web Trim (Non Structural) on T2.

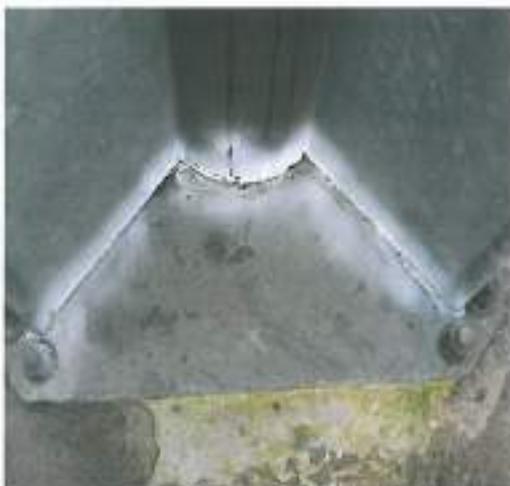
Photographic record showing 1 of 4 inspection segments of Tower 4. No Indications were found and no restrictions encountered.

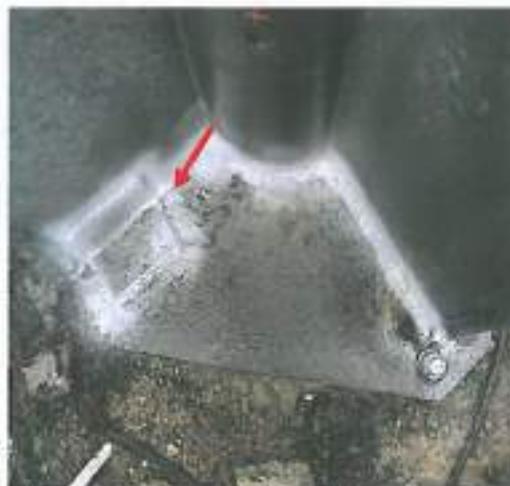
Photographic record showing Extra "L-Plate" weldment to Stiffener web on Tower 7. No Restrictions were encountered and No Indications found.

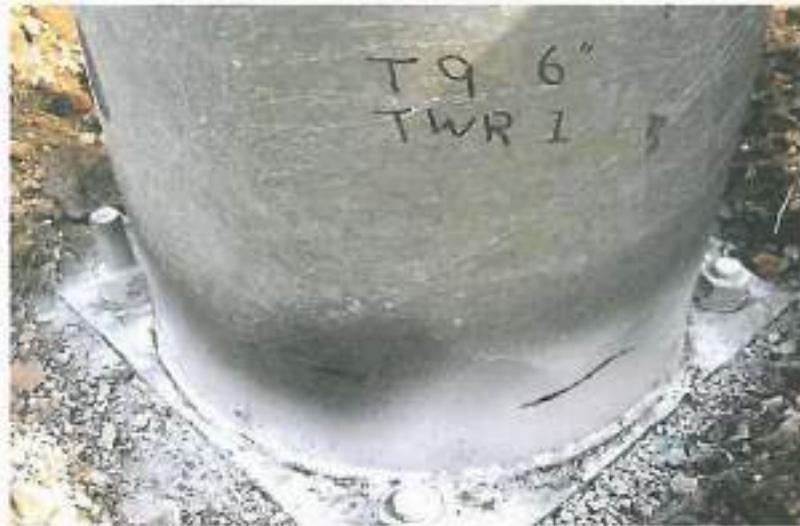
Photographic record of Base Plate Connection weld to Tower 1 looking down-hill (6 o'clock). No restrictions were encountered and no indications found.

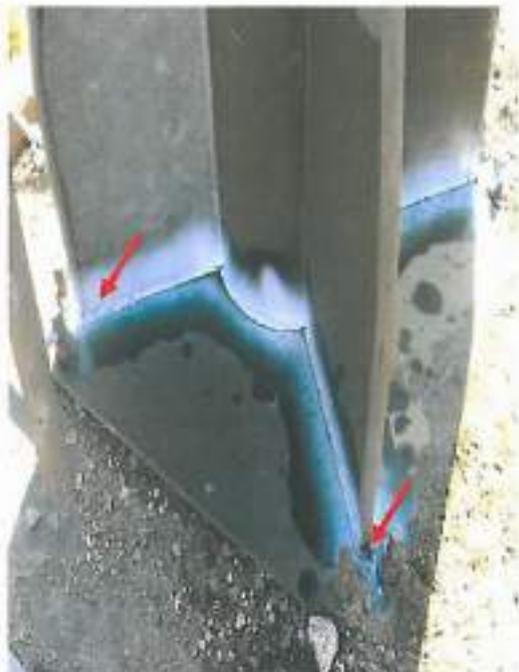
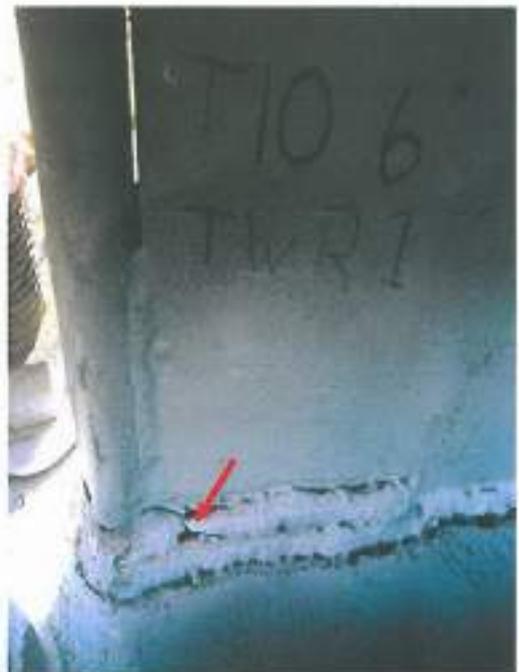
Tow 10 – T1 Porosity found and a 15mm and a 20mm defect found in base weld  
T13 Porosity found and a 4mm and a 30mm defect found in base weld  
T5 Porosity found in base weld

<p>Photographic record of Base Plate and Anchor Bolts on Tower 1. Indications found on both Stiffener Webs facing down-hill.</p>	<p>Photographic record showing 20mm indication on downward Left hand Stiffener web on Tower 1.</p>

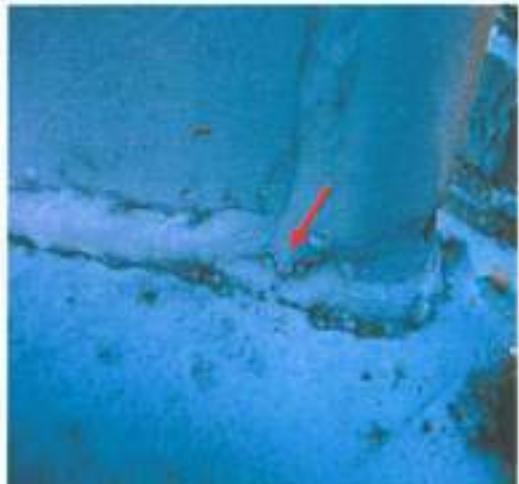
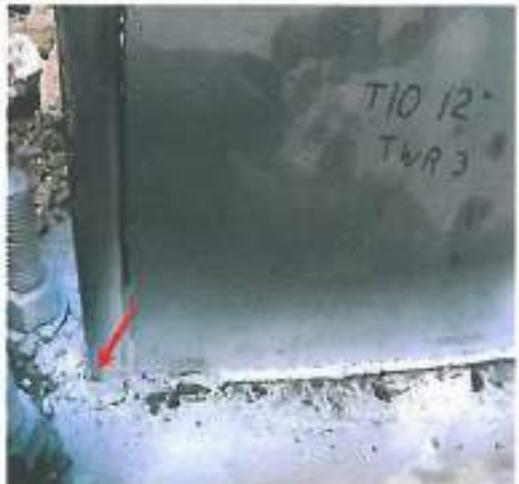
<p>Photographic record showing 15mm indication on downward web right hand side Tower 1.</p>	<p>Photographic record showing 4mm indication on Stiffener to Deck Connection weld on Tower 3 Up-hill right hand side.</p>
