Typical pot bearing

Job name: **Factual report on the sliding bearings to the Funicular Railway.**
Job number: **18013**
Client: **Cairngorm Mountain Ltd**
Engineer: [REDACTED]
Date: **August 2018**

Project 18013, Ancon Bearings inspection on Cairngorm Funicular Railway - August 2018

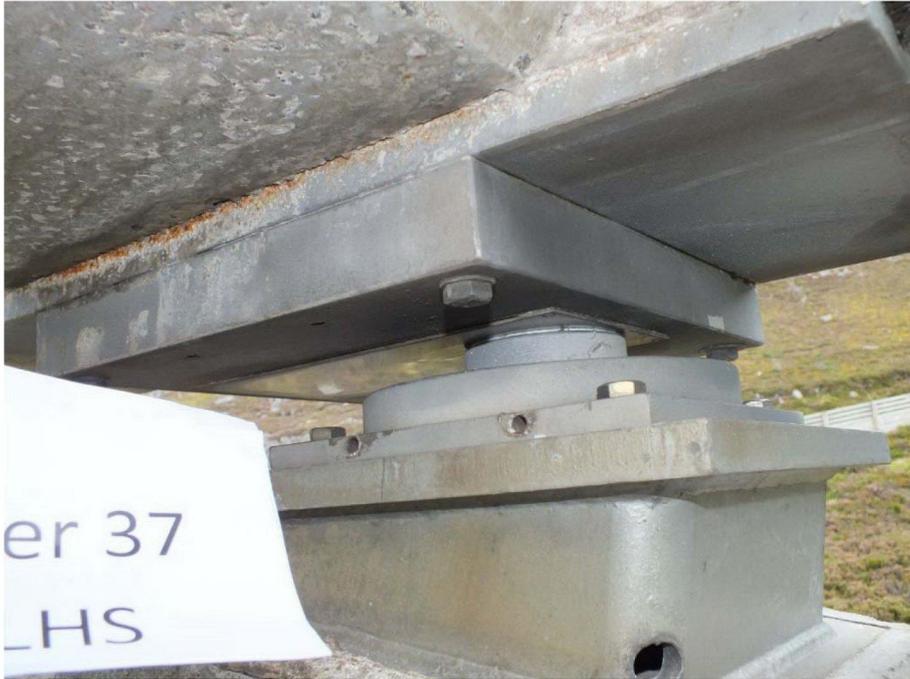
Photo P37 LHS

Bearing at pier 37, LHS

Near end of wearing plate.

Note PTFE appears in good order.

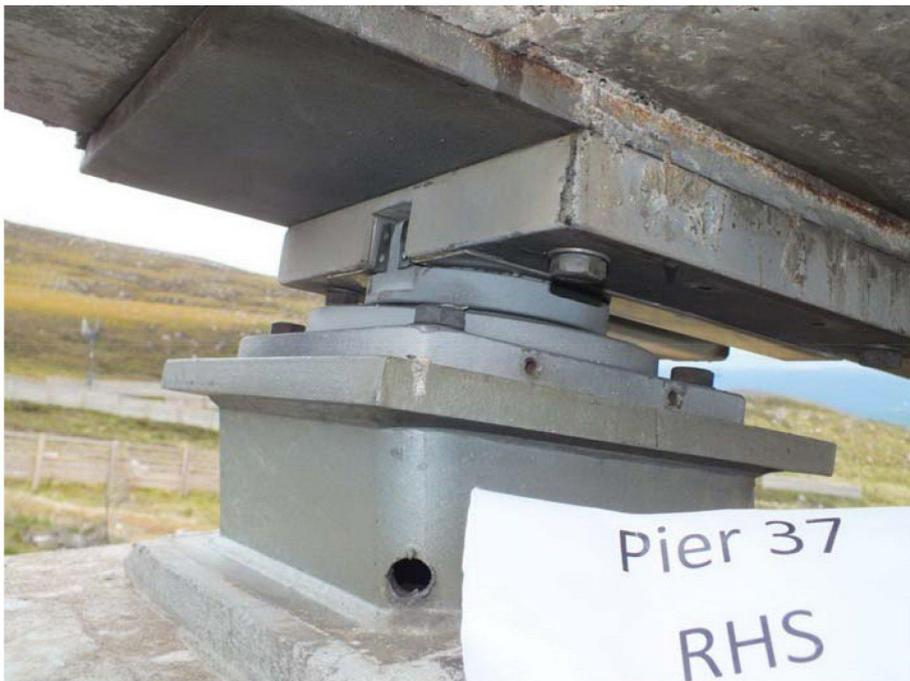
Photo P37 LHS

Bearing at pier 37, RHS.

Near end of travel

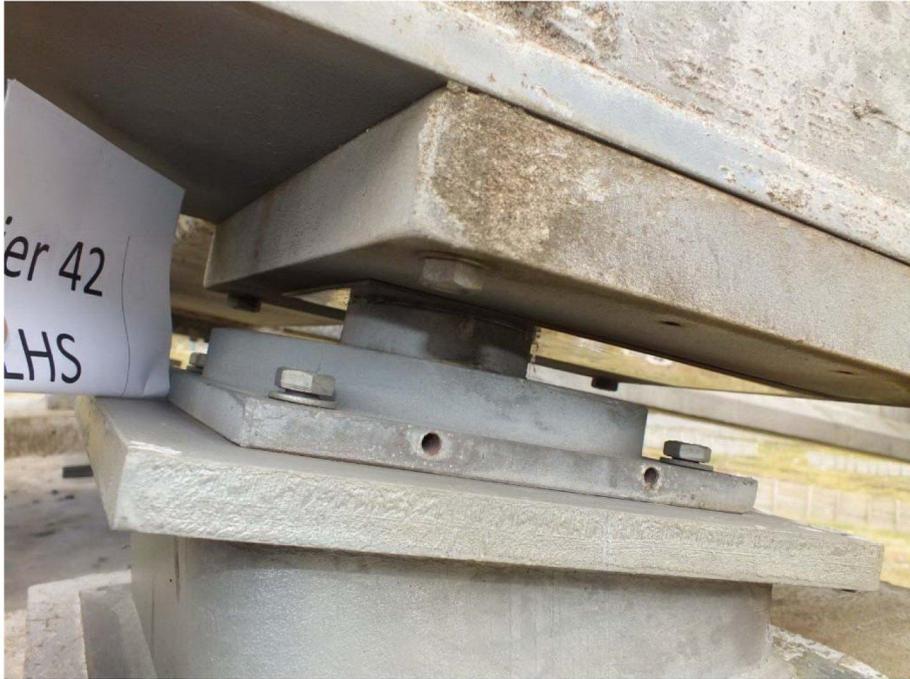
Photo P42 LHS

Bearing at pier 42, LHS

Note bolts appear loose.

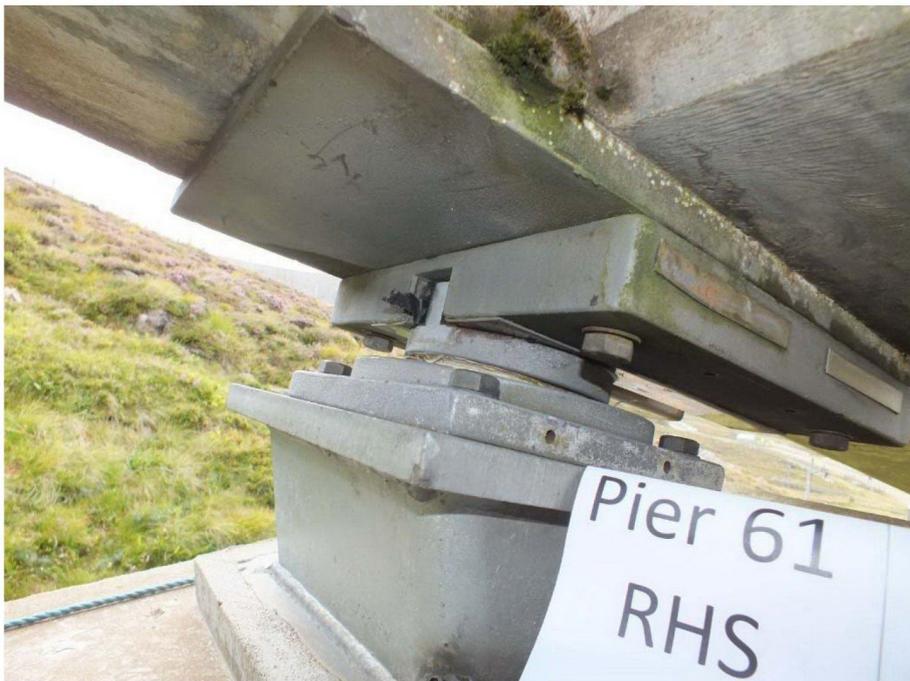
Photo P61 RHS

- 5.6 In addition, there were a number of damages and defects observed as follows:
 - 5.6.1 Pier 51 guided bearing, ripped transverse slip membrane
 - 5.6.2 Pier 61 guided bearing, ripped transverse slip membrane

Bearing at pier 61, RHS.

Transverse slip material
ripped.

- 7.4 There are various individual defects at seven locations, these should be addressed individually, ref section 5.6.

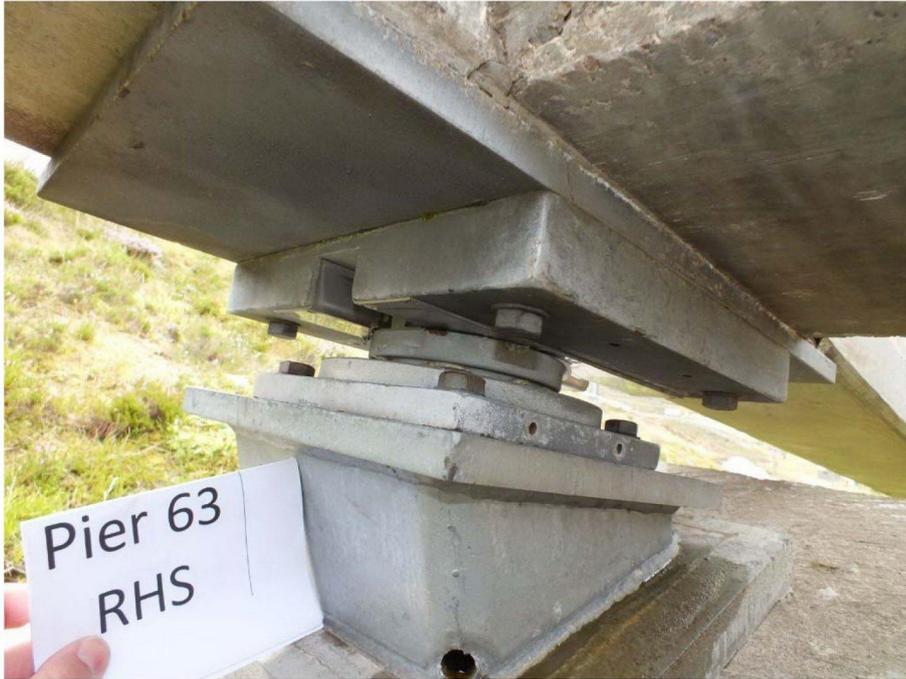
- 5.6.3 Pier 63 pot bearing, PTFE popped out of housing
 - 5.6.4 Pier 70 pot bearing, possible weld fracture in support bracket – note these brackets were not generally inspected for such defects and a wider specific inspection should be undertaken if these are proved to be fractures.

Photo P63 RHS
Bearing at pier 63, RHS
PTFE popped out at rear.

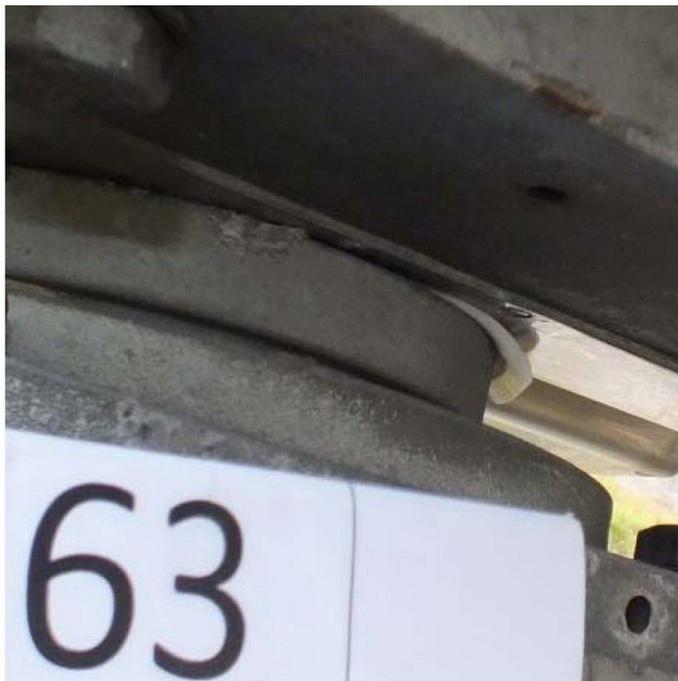
Photo P63 RHS
Bearing at pier 63, RHS
Detail of PTFE popped out at rear.

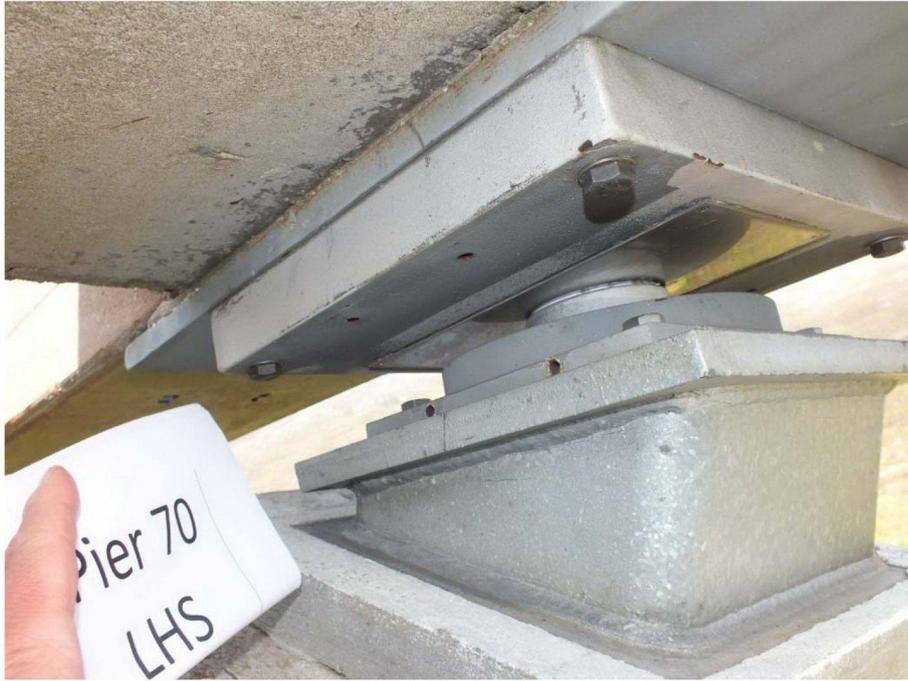
Photo P70 LHS

Bearing at pier 70 LHS

Cracking in steelwork

- 8.3 One steel bearing support bracket was thought to be showing cracking in the face and in the weld (ref p B9). This location should be inspected by a specialist in this field and if it is found to be the case then this should be repaired and an inspection program initiated to look at the other brackets.
- 8.4 The writer has also been involved in annual inspections of the general concrete support structure and there are now several years worth of records. It would be a useful exercise to collate all observations along with as built information on the structure to try and identify patterns in the defects being observed.

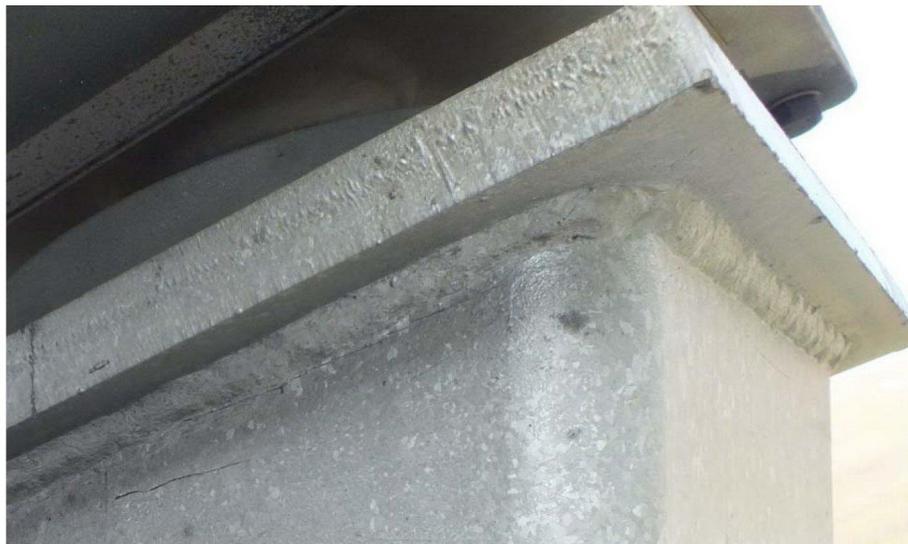
Photo P70 LHS

Bearing at pier 70 LHS

Detail of cracking in steelwork. Not particularly clear, but running along weld and also across face of steel SHS upright.

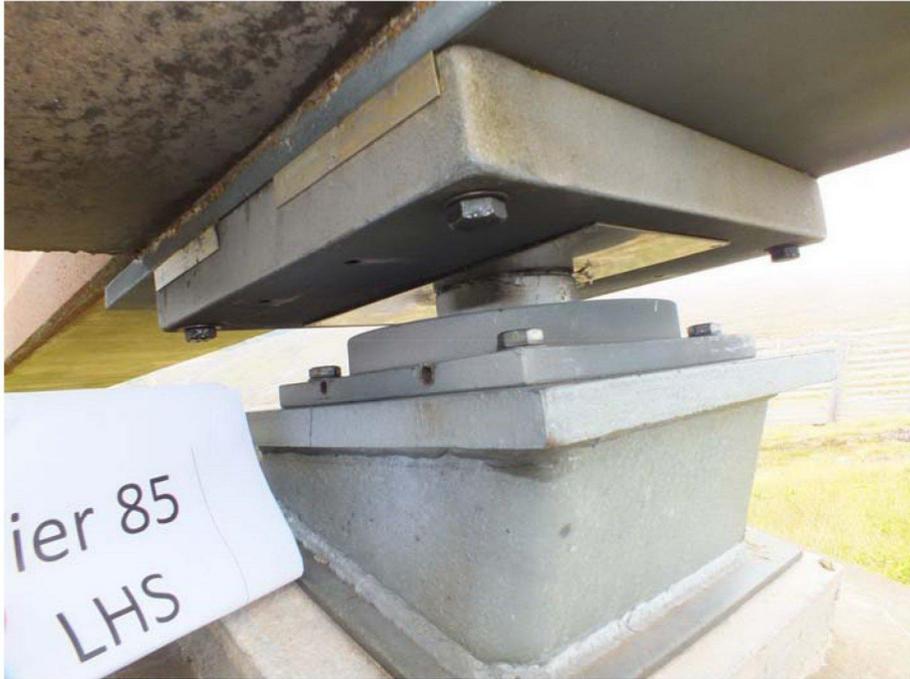
Photo P85 LHS

Bearing at pier 85, LHS

Note PTFE appears very thin, this was recorded as 1.0mm.

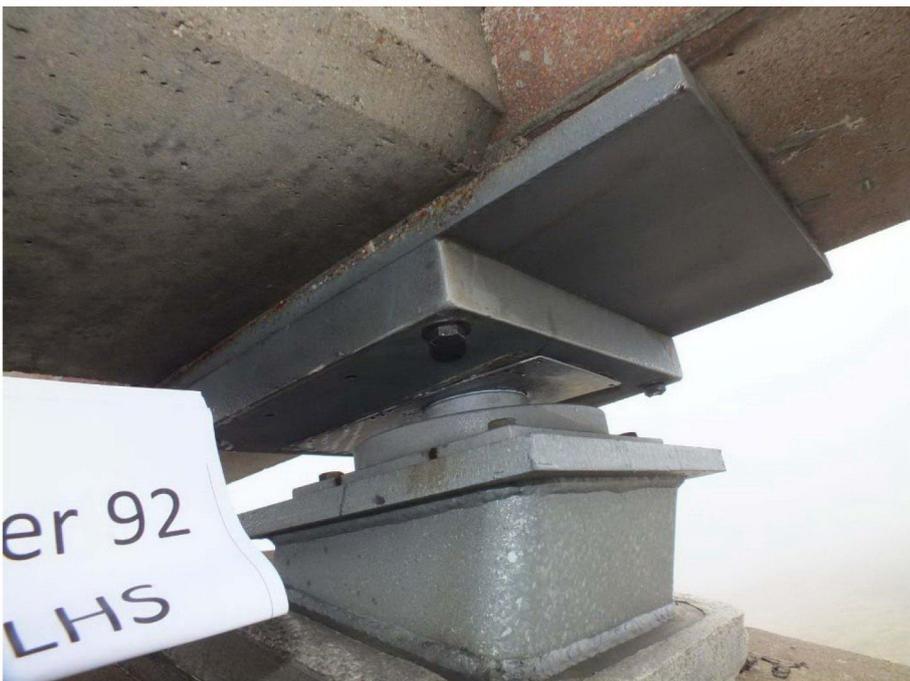
Photo P92 LHS

- 5.6.5 Pier 91 guided bearing, ripped transverse slip membrane
 - 5.6.6 Pier 92 pot bearing, st/st bearing plate detached from support and partially rotated

Bearing at pier 92, LHS.

Note stainless steel wearing plate's fixings have failed and this plate is unrestrained and has moved and rotated.

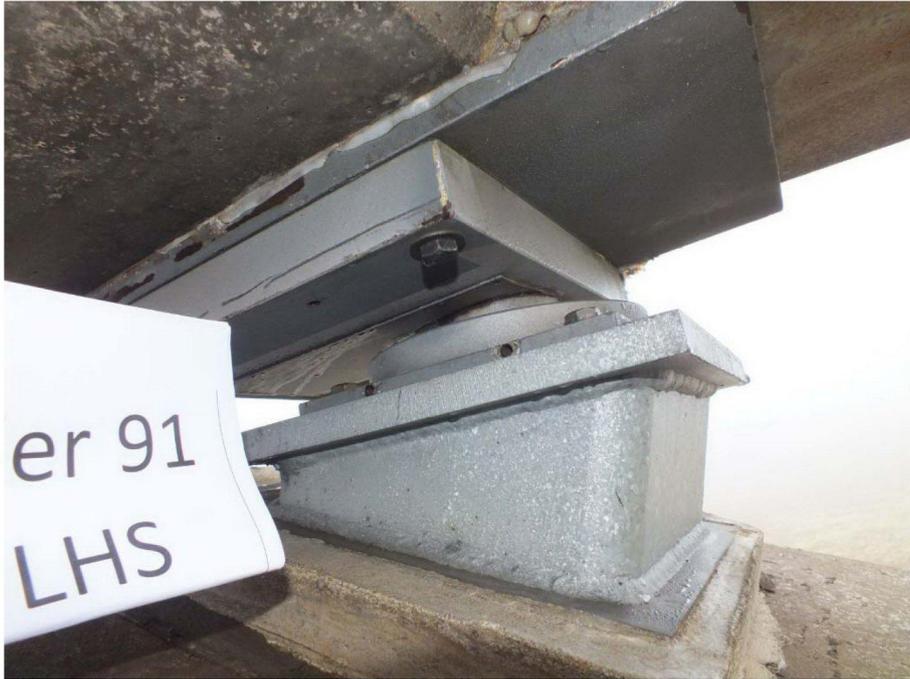
Photo P91 LHS

Bearing at pier 91, LHS

Note pot bearing is at end of wearing plate. PTFE thickness recorded here as 0.0mm.

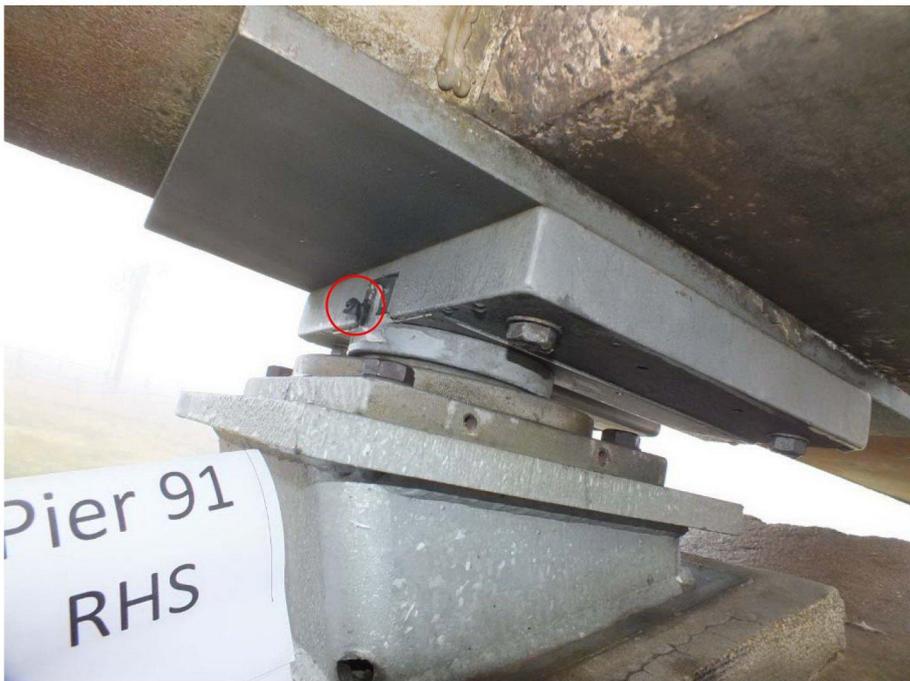
Photo P91 RHS

Bearing at pier 91, RHS.

Note guide and bearing at edge of wearing surfaces. Also note ripped transverse slip material in red circle.

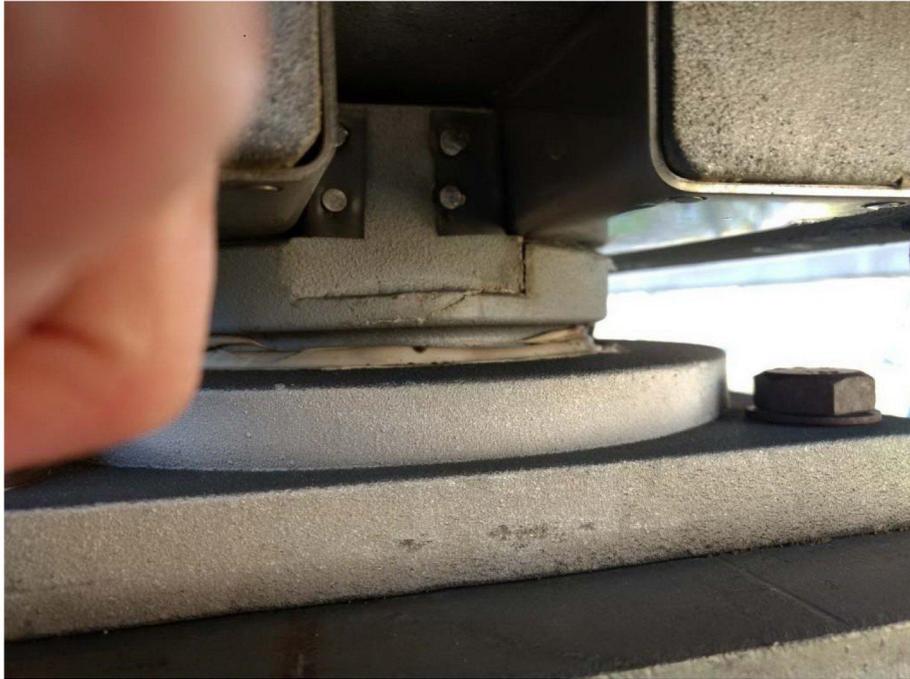
Photo P50 RHS

- 5.6.7 Pier 94 pot bearing, seen to be rusting
 - 5.6.8 Pier 50 guided bearing steel guide appears fractured from integral support plate ref photos on pB12 – note these plates were not generally inspected for such defects and a wider specific inspection should be undertaken if these are proved to be fractures.

Bearing at pier 50, RHS

Viewed from the uphill side, cracking of guide plate. Note "bar" and disc plate are generally one piece, possibly a casting.

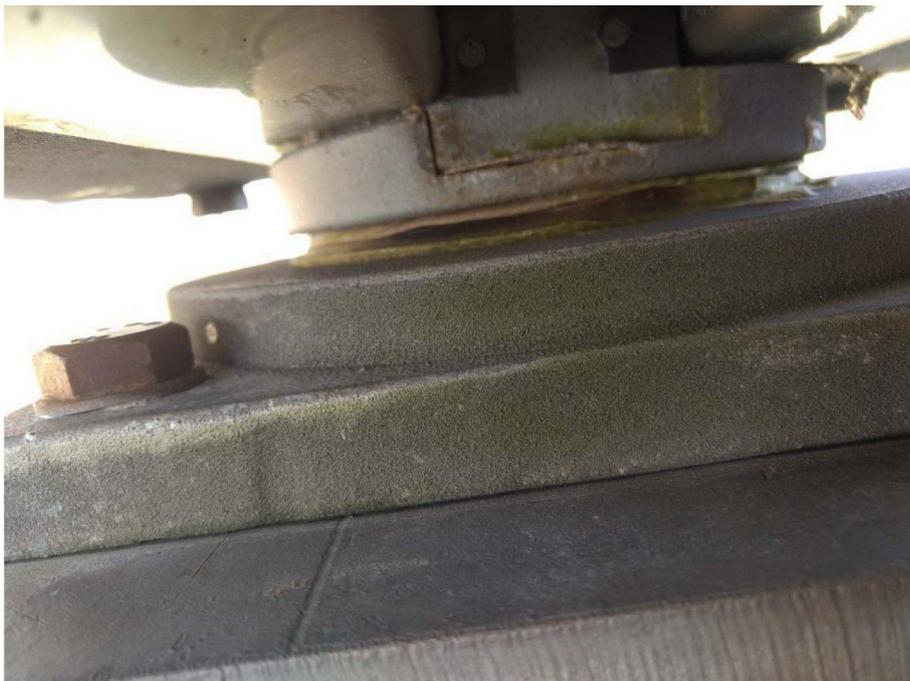
Photo P50 RHS

Bearing at pier 50, RHS

Viewed from the downhill side, cracking of guide plate.
