CAIRNGORM FUNICULAR RAILWAY

VIADUCT STRENGTHENING REPORT

PROJECT NO. A116993
DOCUMENT NO. Rp03

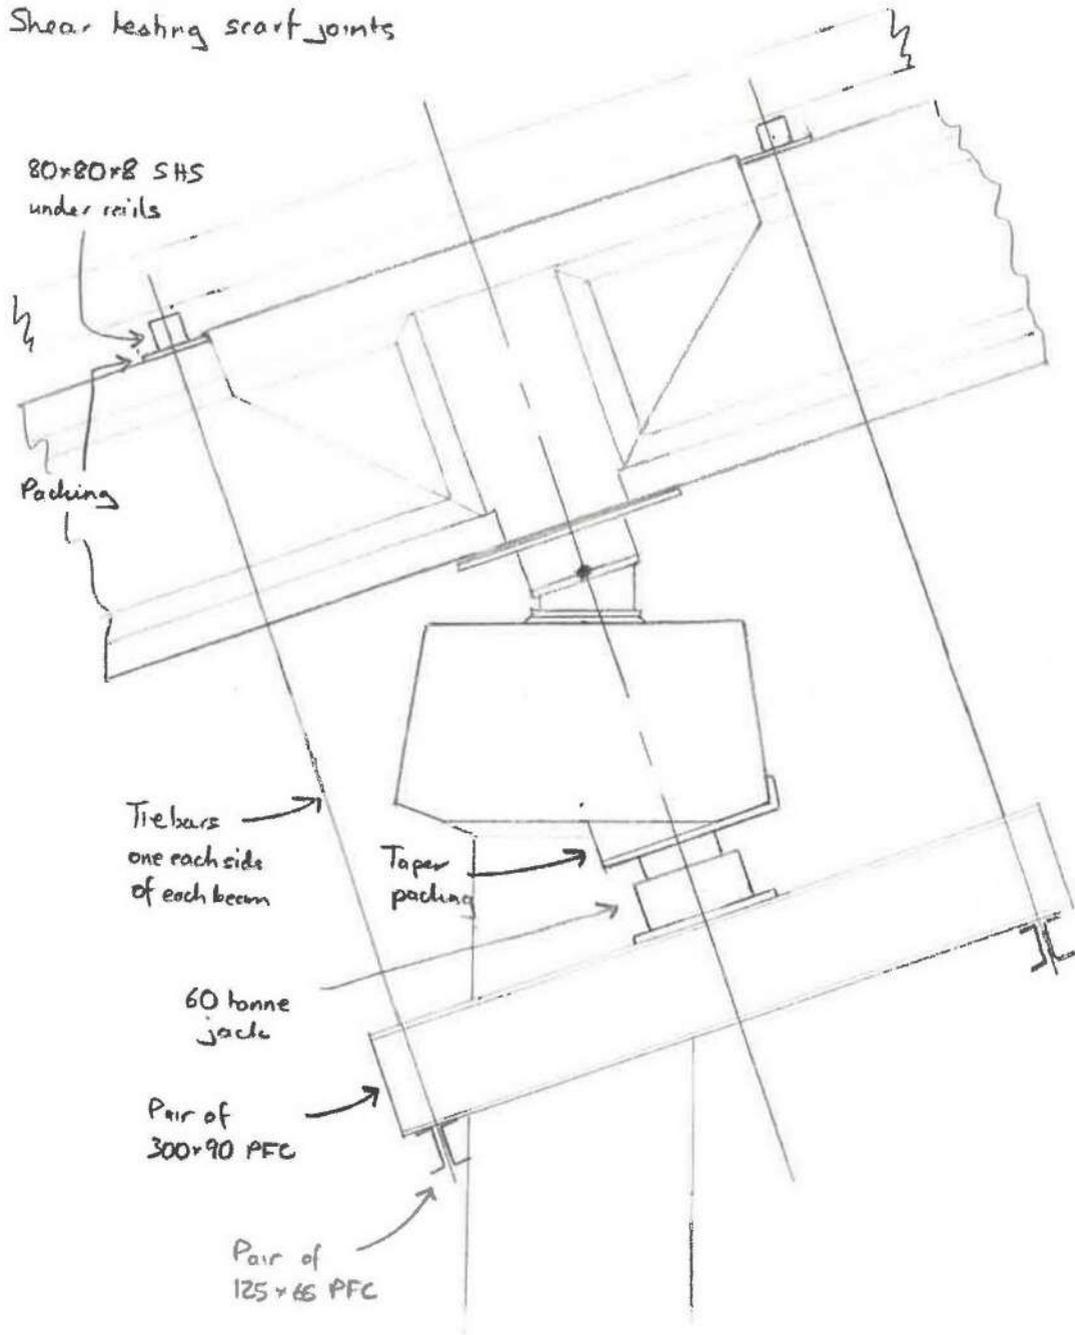
Shear testing scarf joints

Peak load to be 1.1 x maximum ULS line shear on scarf joint

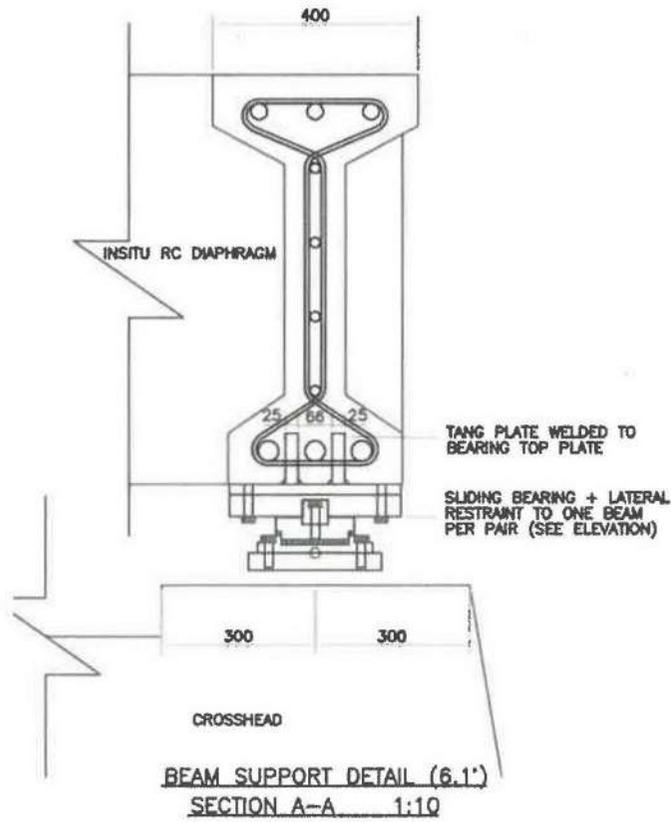
Figure 3 Cross-section of rail support beam at bearing location (guided bearing shown).

At the top connection, the bearings are bolted to 20 mm thick plates on the rail support beam soffit. "Tang" plates are welded to the soffit plates and embedded into the in-situ joint concrete (Figure 3 and Figure 4).

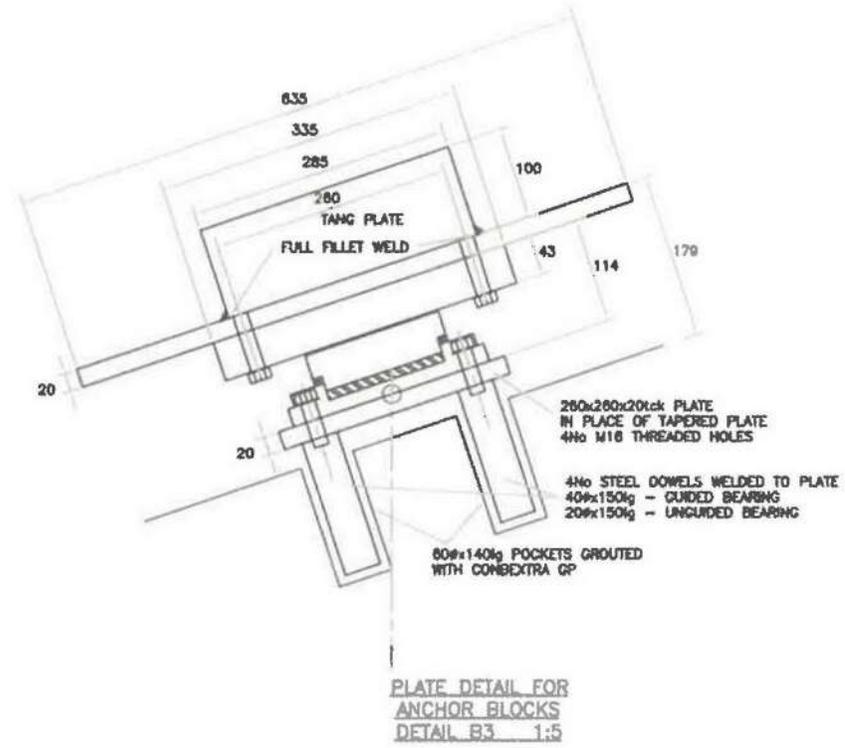
Figure 6 Bearing detail at anchor blocks

At the anchor blocks (i.e. just below the movement joints) tapered plates / steel shoes are not used as the inclination of the anchor block concrete face approximately matches that of the rail support beams. The bearings are therefore bolted to flat plates that are welded to dowels penetrating into the anchor blocks (Figure 6).

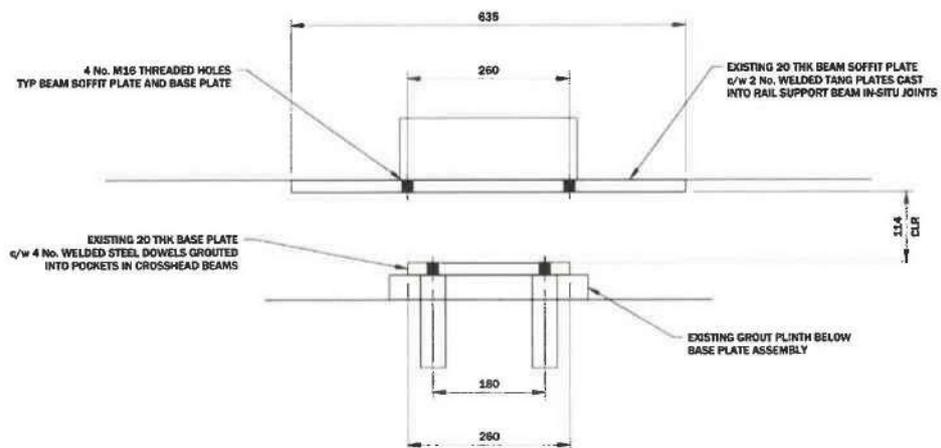
Figure 1 Sketch highlighting typical fixing dimension details – longitudinal section

The existing fixing details are summarised in Figure 1 and Figure 2. These are indicative and merely shows the typical bolt spacing of upper and lower plates. Note that the base plate configuration shown is replaced by a built-up hollow section bearing shoe at some piers, but the bolted connection details remain the same. The key constraints are as follows:

- > The existing beam soffit plate is 635mm long. The new bearing top plate and sliding surface must fit within this length while still allowing for the full translation demand due to misalignment plus thermal movements.

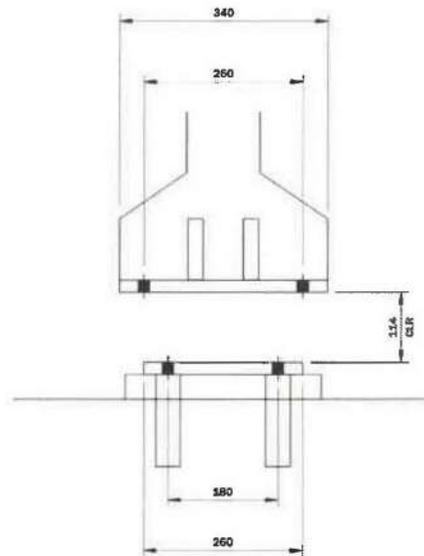
Figure 2 Sketch highlighting typical fixing dimension details – transverse section

- > The existing base plate has four M16 bolts at 180mm square. Additional bolts can be added to site-drilled threaded holes, but the new bolt pattern must remain within the 180mm square area. Wider bolt spacing would either interfere with the hollow sections (at the locations with bearing shoes) or prevent the minimum edge distance from being achieved.

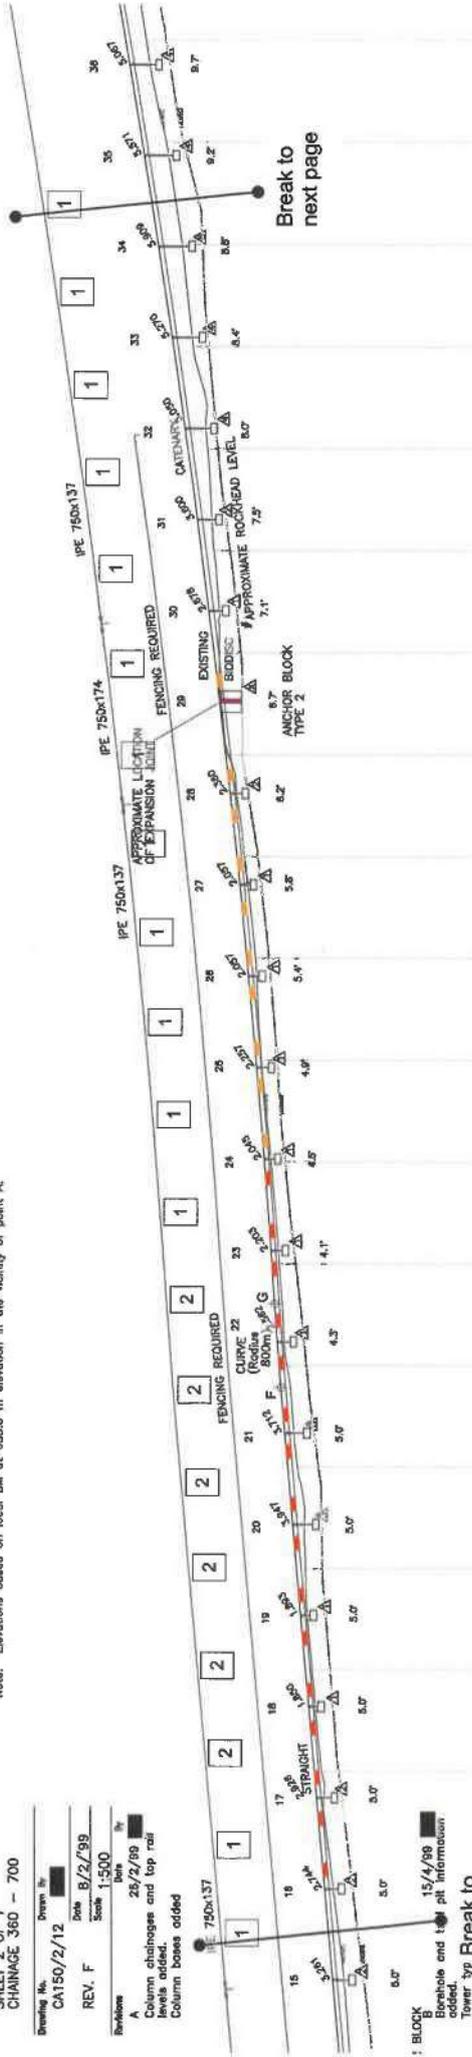
- Beam type**
- 1 Requires strengthening at 1st & 2nd crossbeams due shear utilisation > 1
 - 2 Requires strengthening at 1st crossbeam due shear utilisation > 1
 - 3 Strengthening recommended at 1st crossbeam due to high shear utilisation
 - 4 Strengthening recommended over piers - connect 25 dia bars to reduce cracking
 - 5 Requires strengthening to anchor block due to bending utilisation > 1
 - 6 Strengthening recommended due to high bending utilisation

- Total this page**
- Brown 0 span ends
 - Red 16 span ends
 - Orange 10 span ends
 - Blue 0 piers
 - Purple 1 anchor block
 - Pink 0 anchor blocks

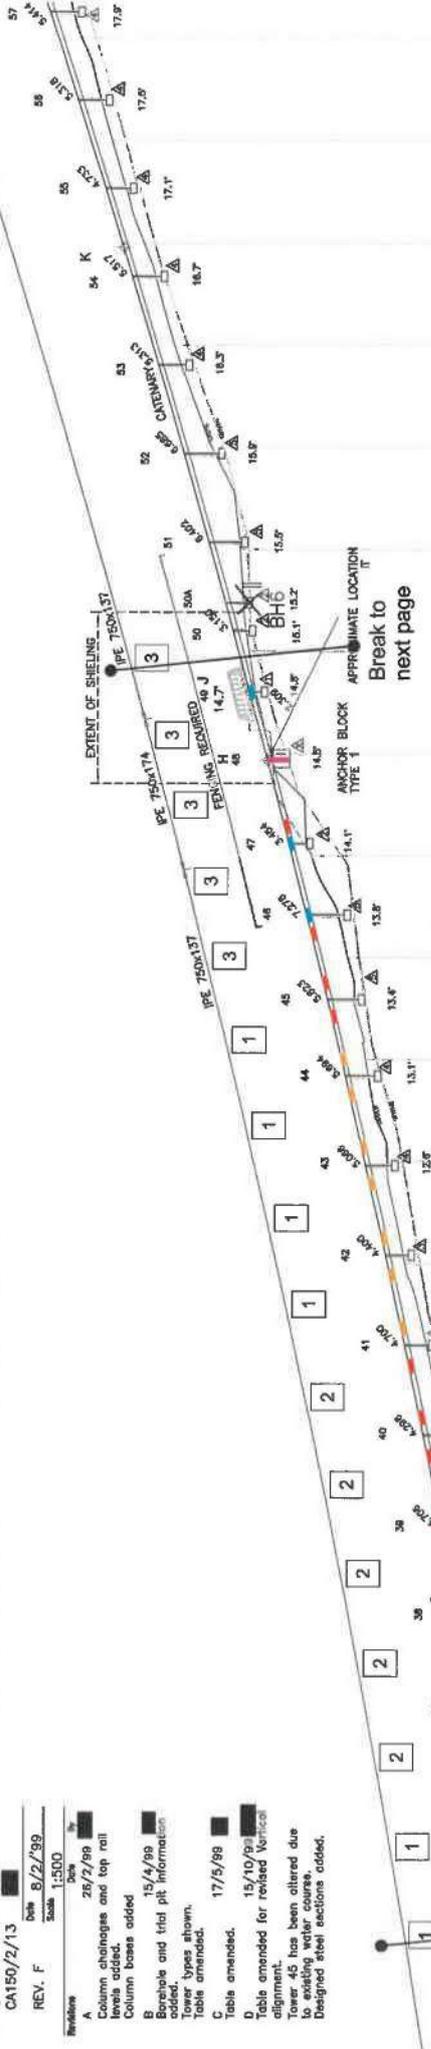
- 1 Beam type
- Requires strengthening at 1st & 2nd crossbeams due shear utilisation > 1
- Requires strengthening at 1st crossbeam due shear utilisation > 1
- Strengthening recommended at 1st crossbeam due to high shear utilisation
- Strengthening recommended over piers - connect 25 dia bars to reduce cracking
- Requires strengthening to anchor block due to bending utilisation > 1
- Strengthening recommended due to high bending utilisation

Total this page
 Brown 0 span ends
 Red 14 span ends
 Orange 9 span ends
 Blue 3 piers
 Purple 0 anchor blocks
 Pink 1 anchor block

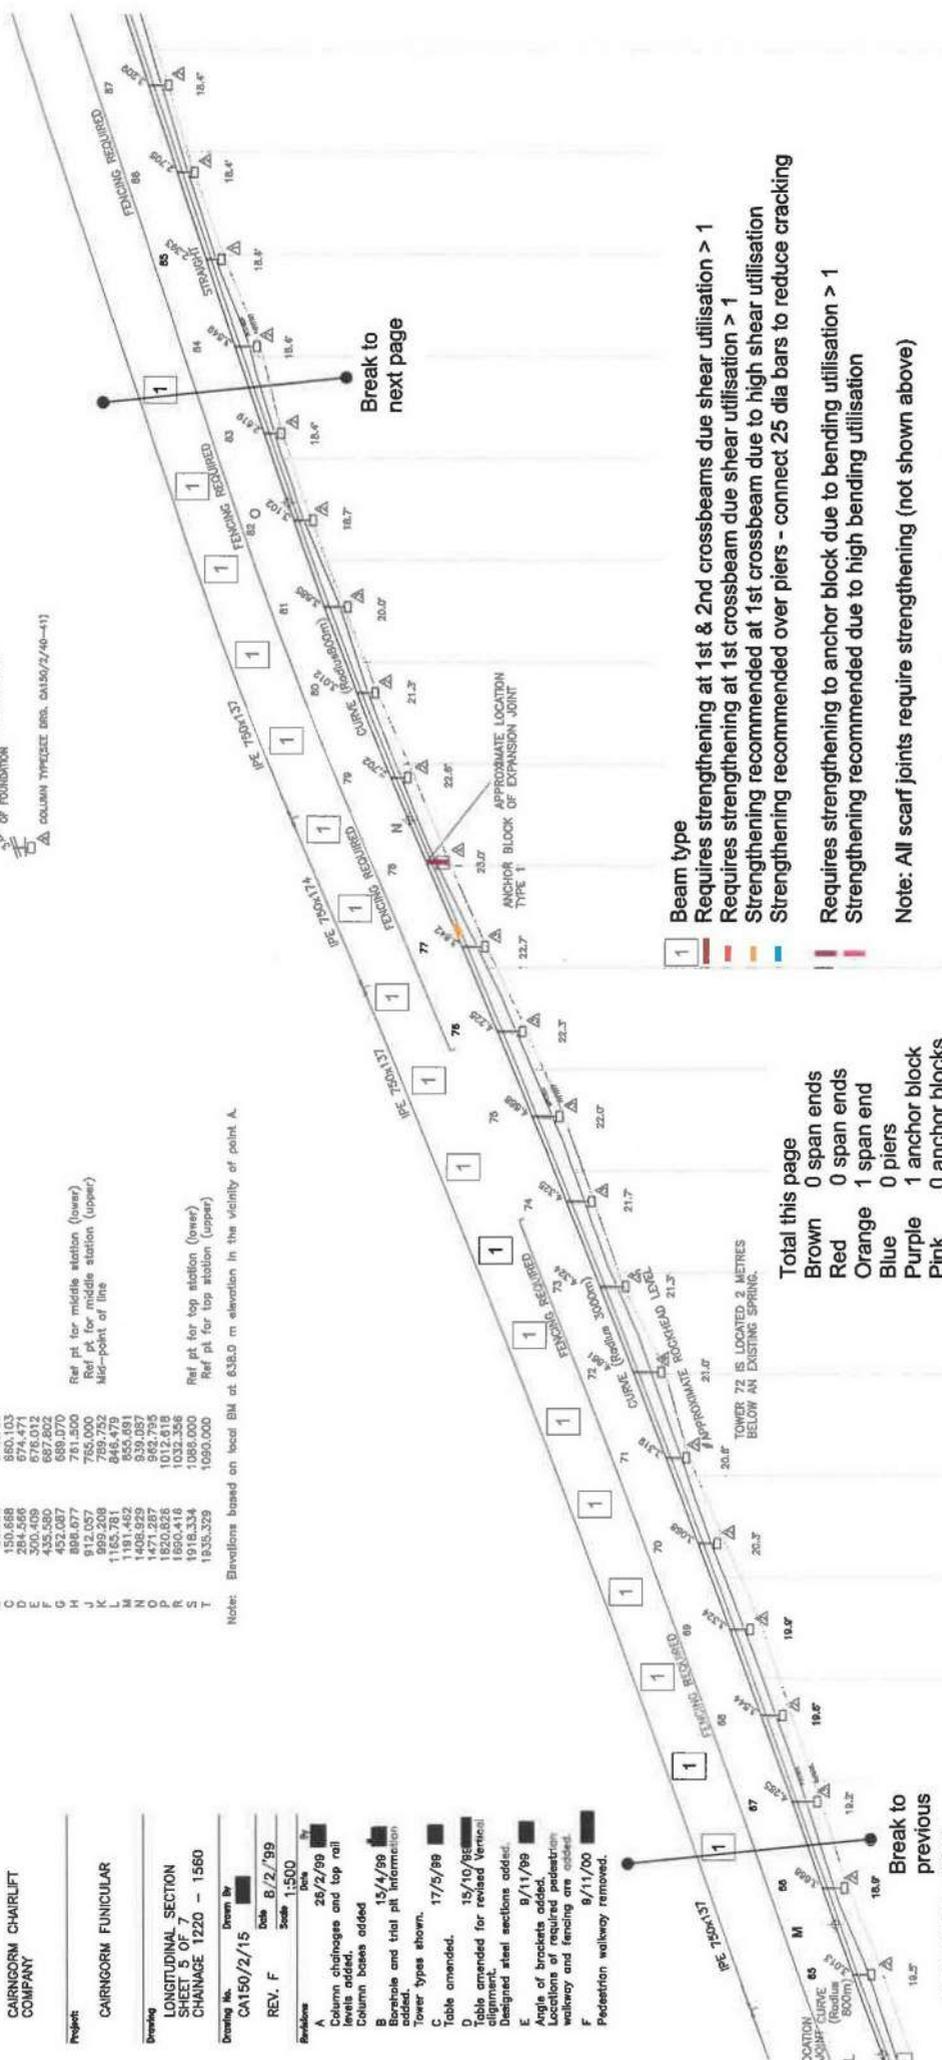
- Beam type**
- 1 Requires strengthening at 1st & 2nd crossbeams due shear utilisation > 1
 - 2 Requires strengthening at 1st crossbeam due shear utilisation > 1
 - 3 Strengthening recommended at 1st crossbeam due to high shear utilisation
 - 4 Strengthening recommended over piers - connect 25 dia bars to reduce cracking
 - 5 Requires strengthening to anchor block due to bending utilisation > 1
 - 6 Strengthening recommended due to high bending utilisation
- Note: All scarf joints require strengthening (not shown above)

- Total this page**
- Brown 0 span ends
 - Red 0 span ends
 - Orange 1 span end
 - Blue 0 piers
 - Purple 1 anchor block
 - Pink 0 anchor blocks

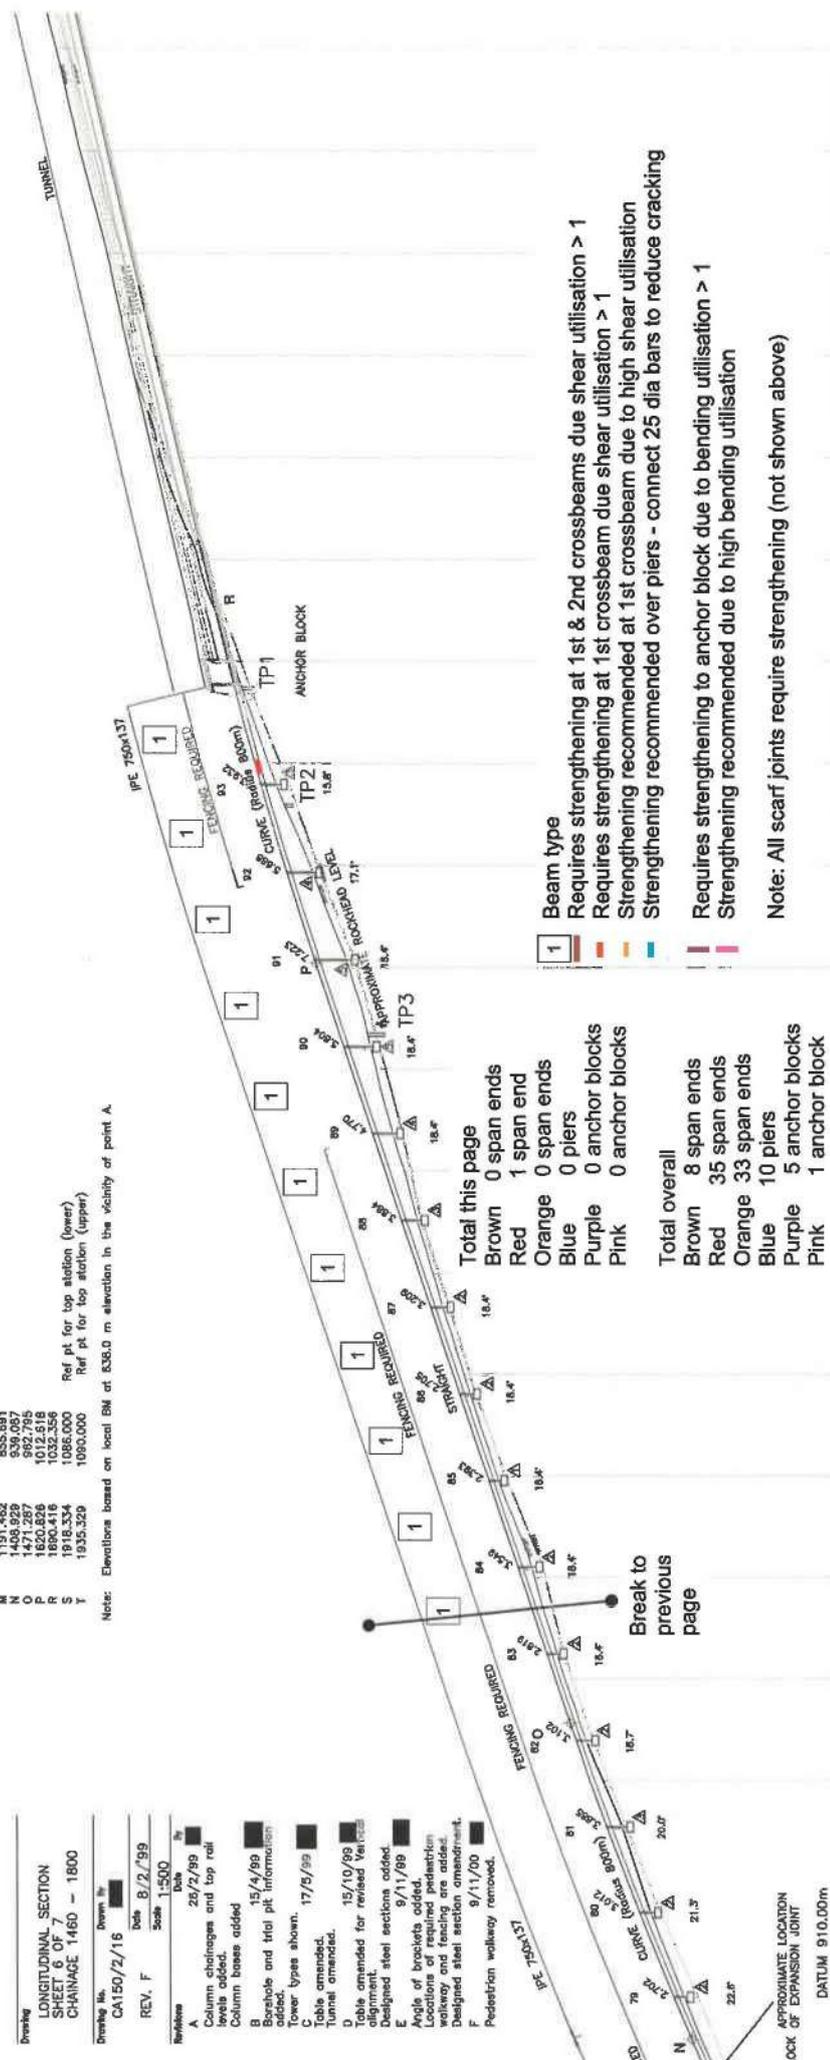
Total this page
 Brown 0 span ends
 Red 1 span end
 Orange 0 span ends
 Blue 0 piers
 Purple 0 anchor blocks
 Pink 0 anchor blocks

Total overall
 Brown 8 span ends
 Red 35 span ends
 Orange 33 span ends
 Blue 10 piers
 Purple 5 anchor blocks
 Pink 1 anchor block
