## Cairngorm Ski Towers Inspection Report

for Highlands & Islands

Job Ref: SJ1021

August 2014

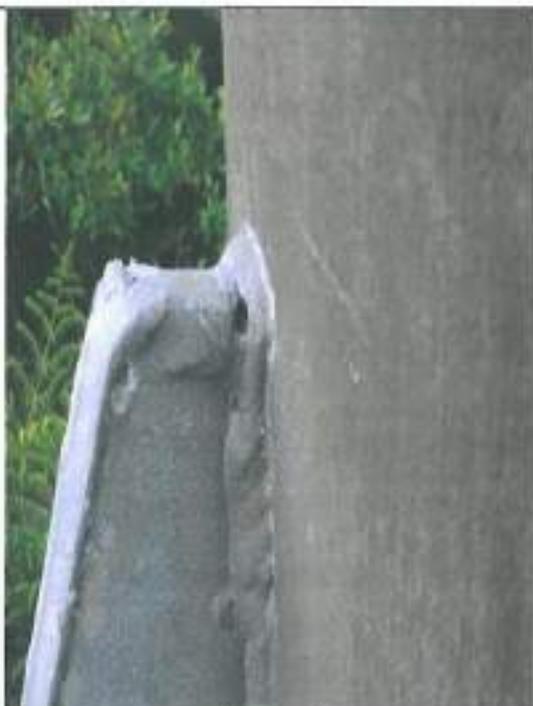
Tower 5

All Anchor Bolts are hand tight with light to moderate corrosion. External fittings up to 3000mm in a safe and orderly condition. Stiffener Web Welds on T5 showed some porosity. Junction Box on T9 hanging off and mechanical damage noted on Stiffener Web Trims.

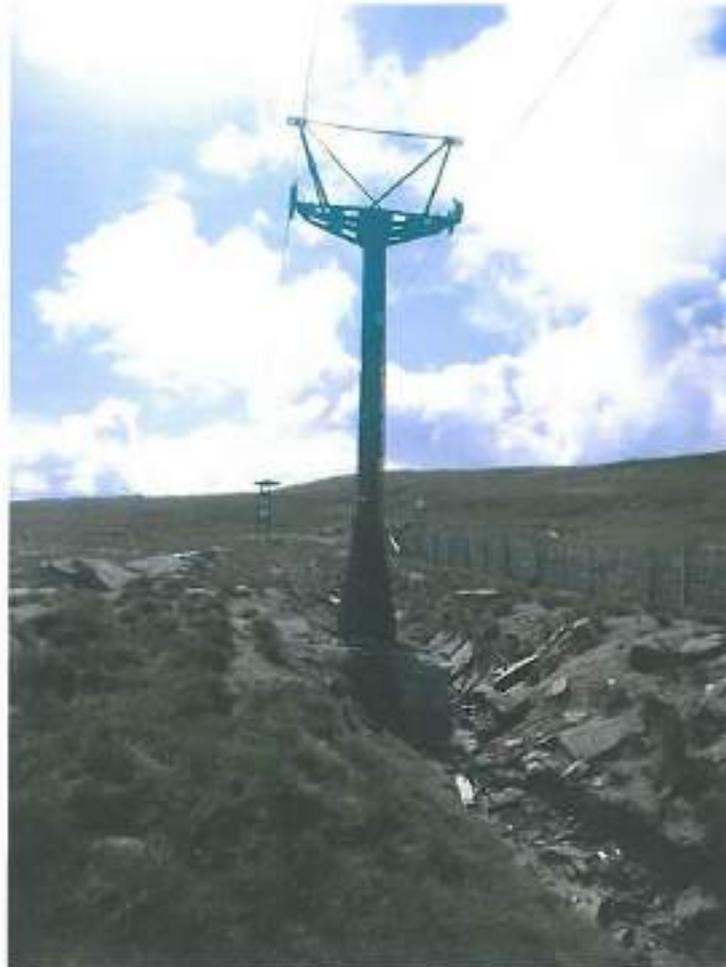
Ptarmigan T-Bar Tower 1

T1	12 o/c	3 o/c	6 o/c	9 o/c
500mm	7.8	7.8	7.3	7.6
3000mm	7.5	7.3	7.8	7.1

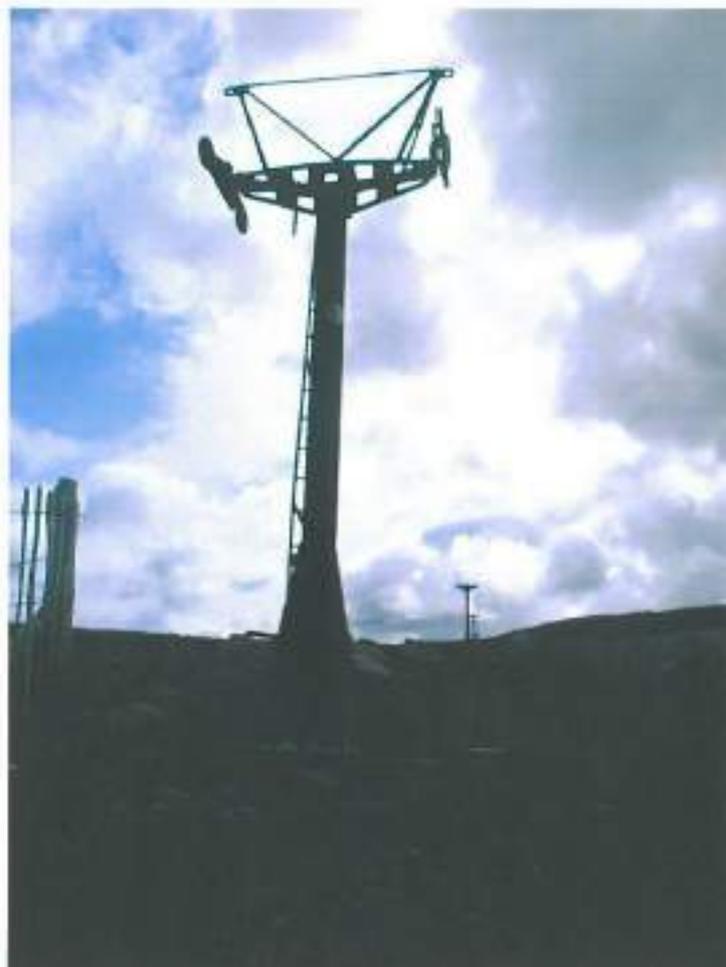
Ptarmigan T- Bar Tower 3

T3	12 o/c	3 o/c	6 o/c	9 o/c
500mm	8.4	8.1	7.5	8.6
3000mm	8.4	8.3	8.2	8.7

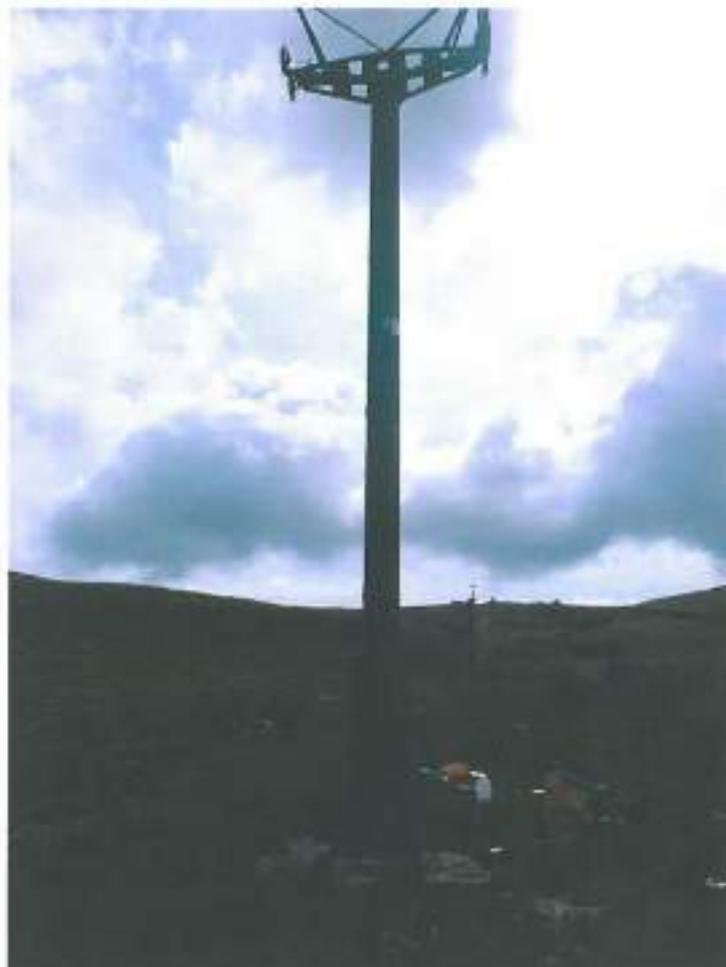
Ptarmigan T-Bar Tower 5

T5	12 o/c	3 o/c	6 o/c	9 o/c
500mm	8.9	8.1	7.3	8.4
3000mm	8.3	8.5	7.6	8.1

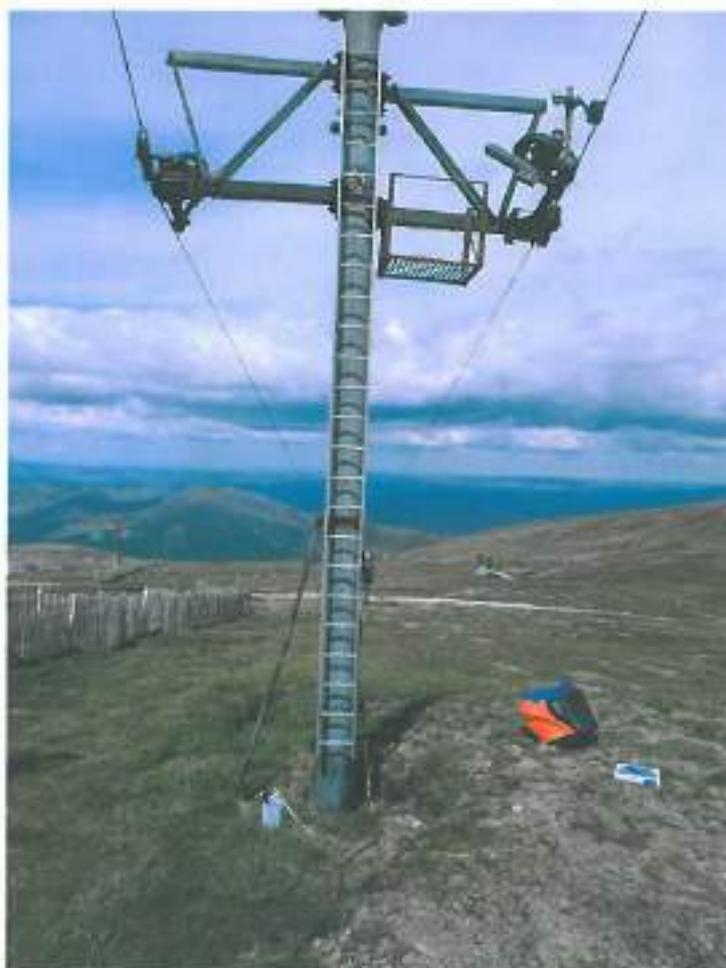
Polar Express Poma Tower 1

T1	12 o/c	3 o/c	6 o/c	9 o/c
500mm	4.9	4.8	4.3	4.4
3000mm	4.5	4.3	4.9	4.6

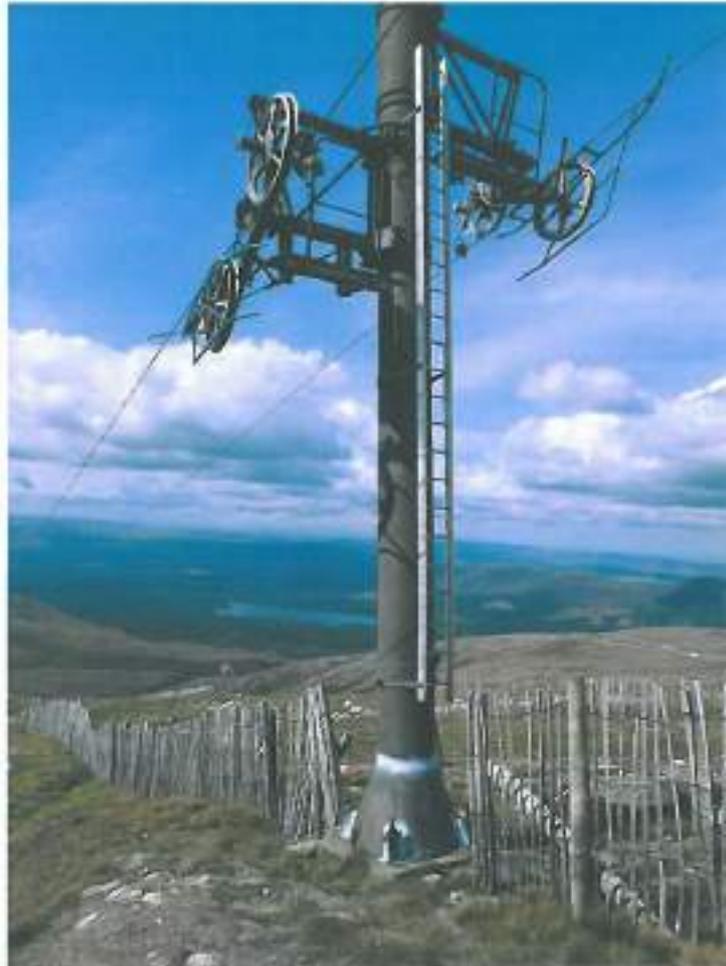
**M1 Poma Tower 2**

T2	12 o/c	3 o/c	6 o/c	9 o/c
500mm	11.1	11.1	11.1	11.2
3000mm	7.4	7.4	7.5	7.7

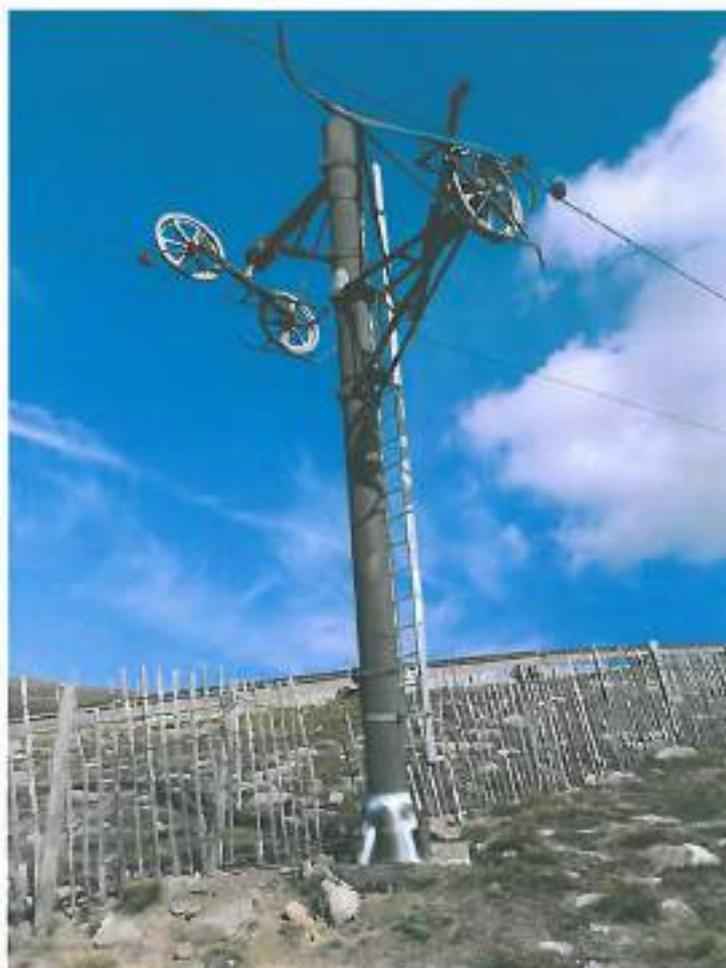
**M1 Poma Tower 7**

T7	12 o/c	3 o/c	6 o/c	9 o/c
500mm	8.2	8.9	8.2	8.2
3000mm	8.8	8.7	8.8	8.7

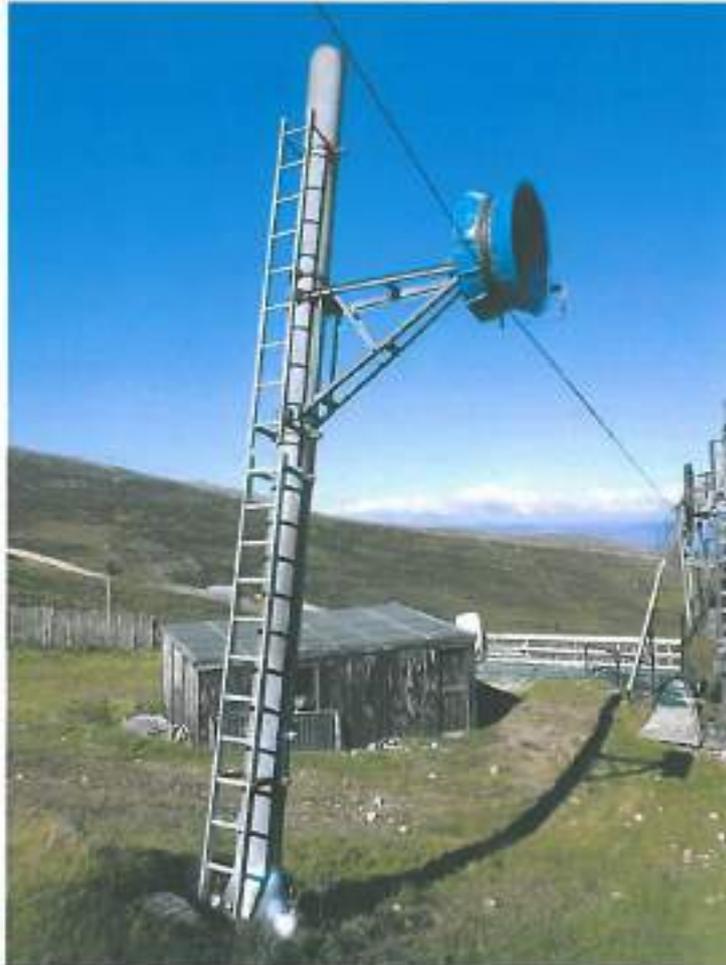
**M1 Poma Tower 11**

T11	12 o/c	3 o/c	6 o/c	9 o/c
500mm	4.5	4.8	5.2	5.2
3000mm	4.9	5.3	4.8	5.3

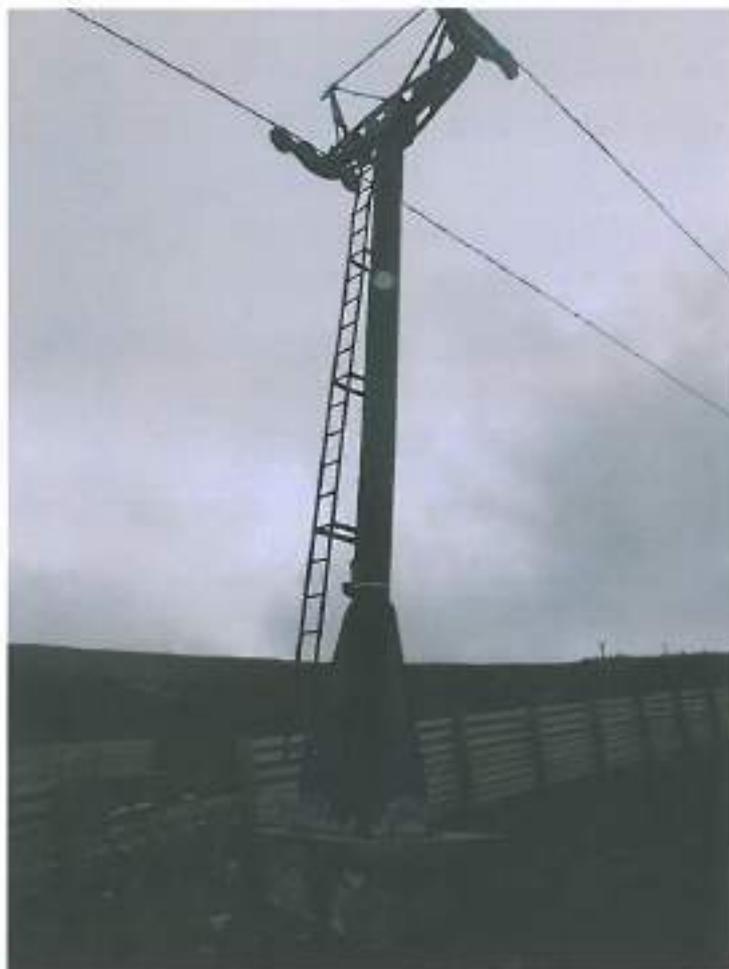
**Coire Na Ciste Tower 2**

<b>T2</b>	<b>12 o/c</b>	<b>3 o/c</b>	<b>6 o/c</b>	<b>9 o/c</b>
<b>500mm</b>	8.7	9	8.6	8.1
<b>3000mm</b>	7.7	8.8	8	7.9

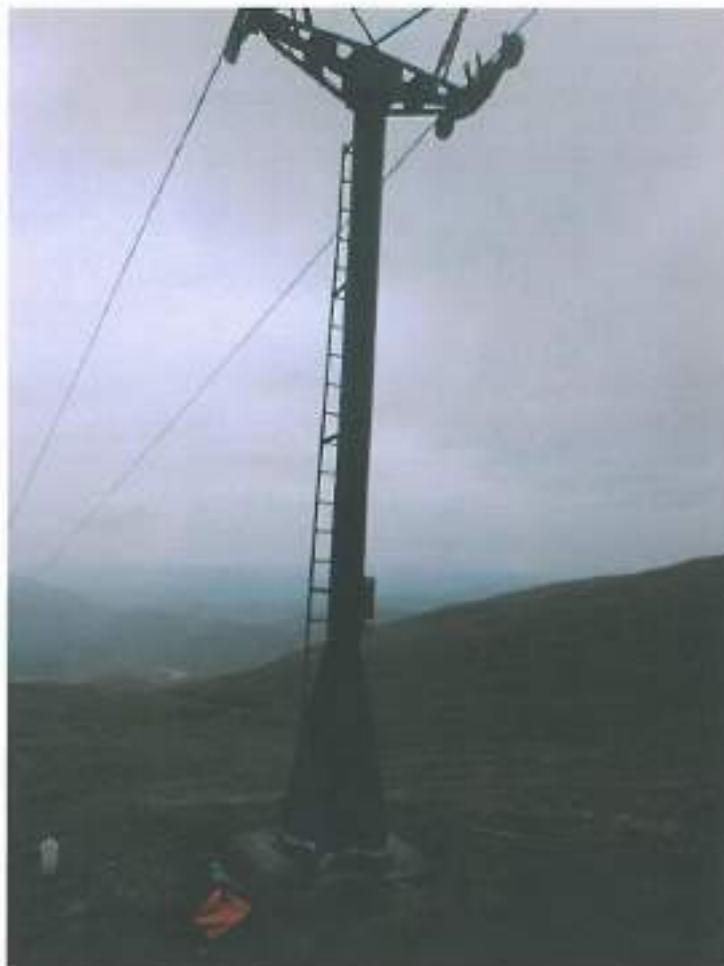
Coire Na Ciste Tower 4

T4	12 o/c	3 o/c	6 o/c	9 o/c
500mm	8.3	8.8	8.3	8.3
3000mm	8.9	9.1	7.8	7.9

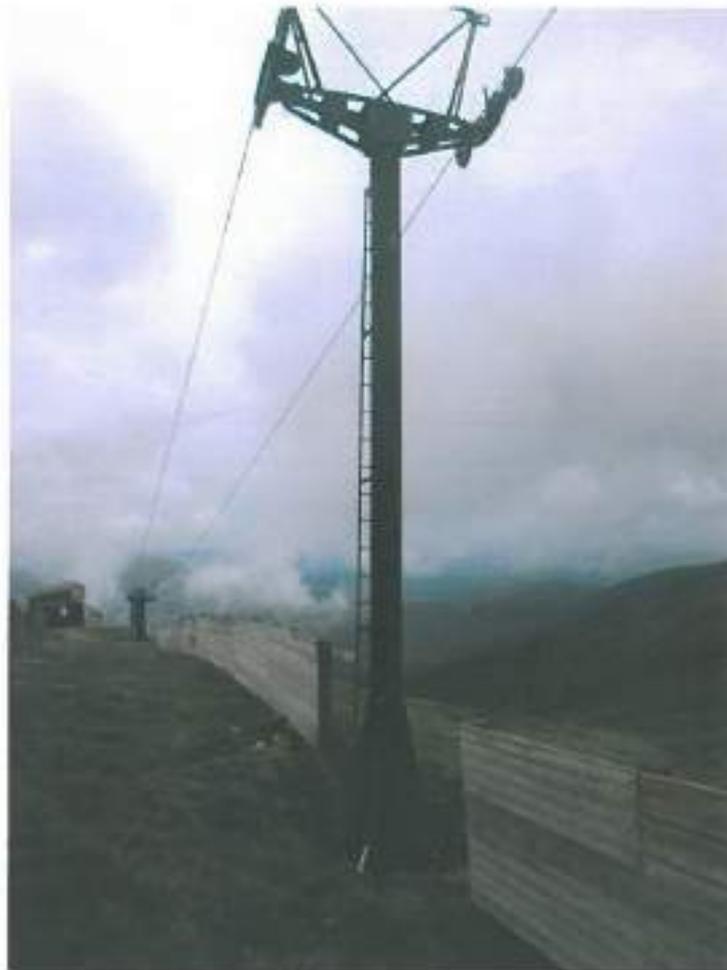
Coire Na Ciste Tower 7

T7	12 o/c	3 o/c	6 o/c	9 o/c
500mm	9.0	9.1	9.2	8.8
3000mm	8.6	8.6	8.9	9.2

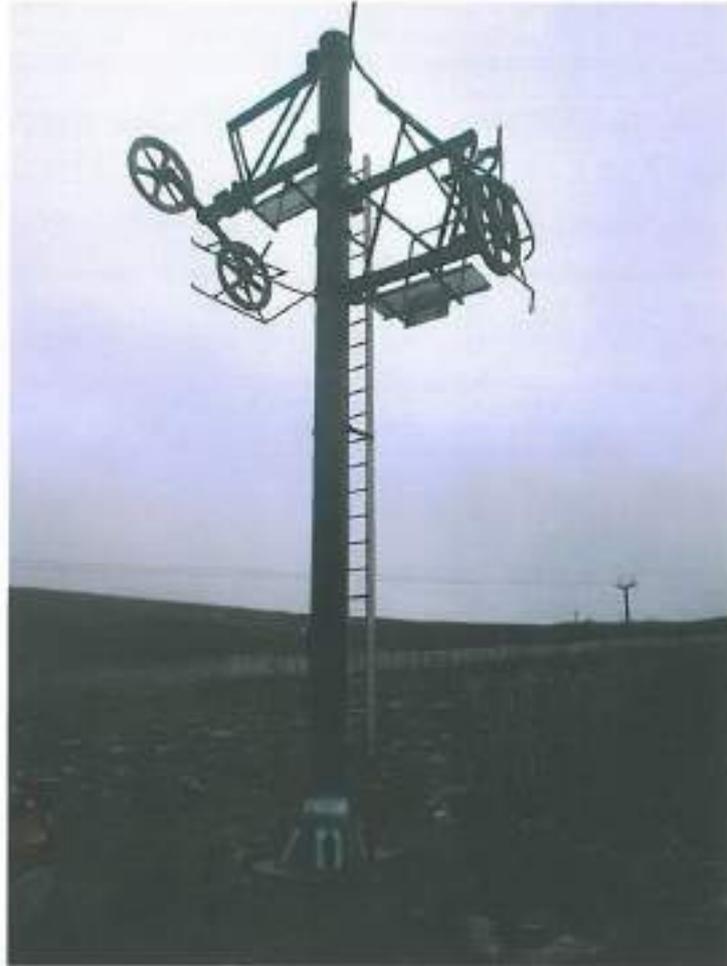
**West Wall Poma Tower 2**

T2	12 o/c	3 o/c	6 o/c	9 o/c
500mm	5.3	5.3	5.8	5.5
3000mm	4.9	5.1	4.8	4.8

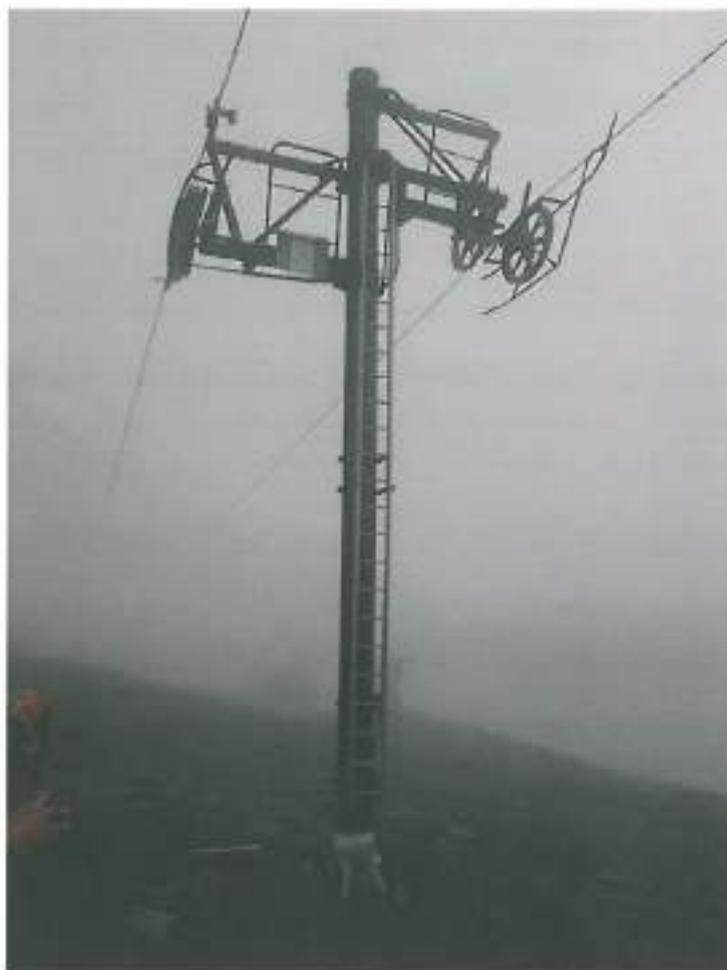
**West Wall Poma Tower 7**

T7	12 o/c	3 o/c	6 o/c	9o/c
500mm	7.4	8.3	8.4	7.7
3000mm	7.2	7.8	7.8	7.8

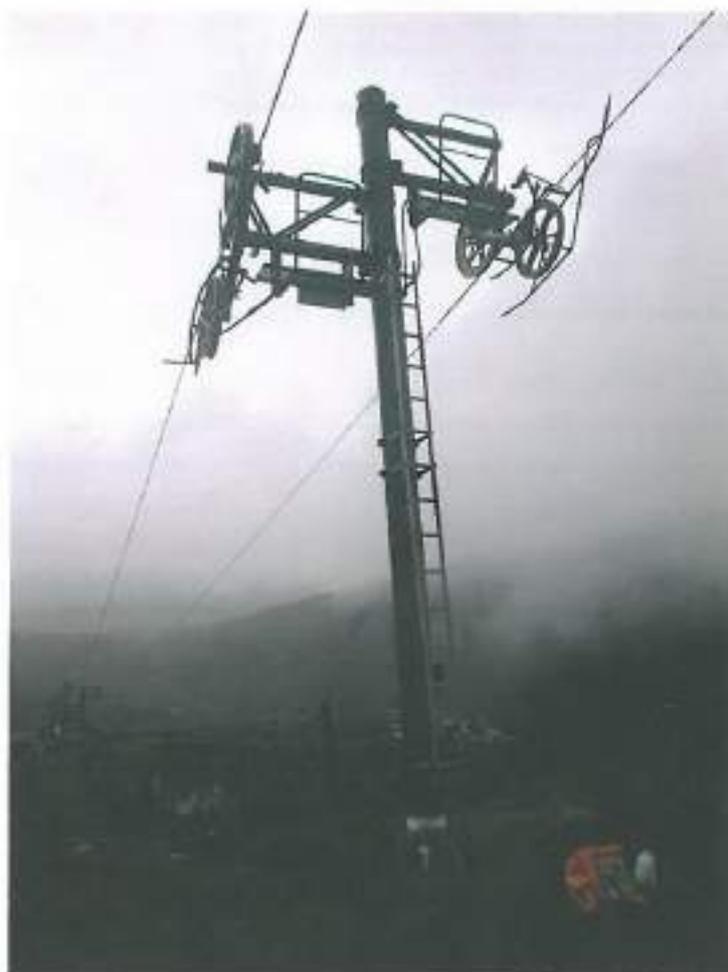
West Wall Poma Tower 15

T15	12 o/c	3 o/c	6 o/c	9 o/c
500mm	4.8	4.8	4.8	5.3
3000mm	4.8	4.9	4.9	4.6

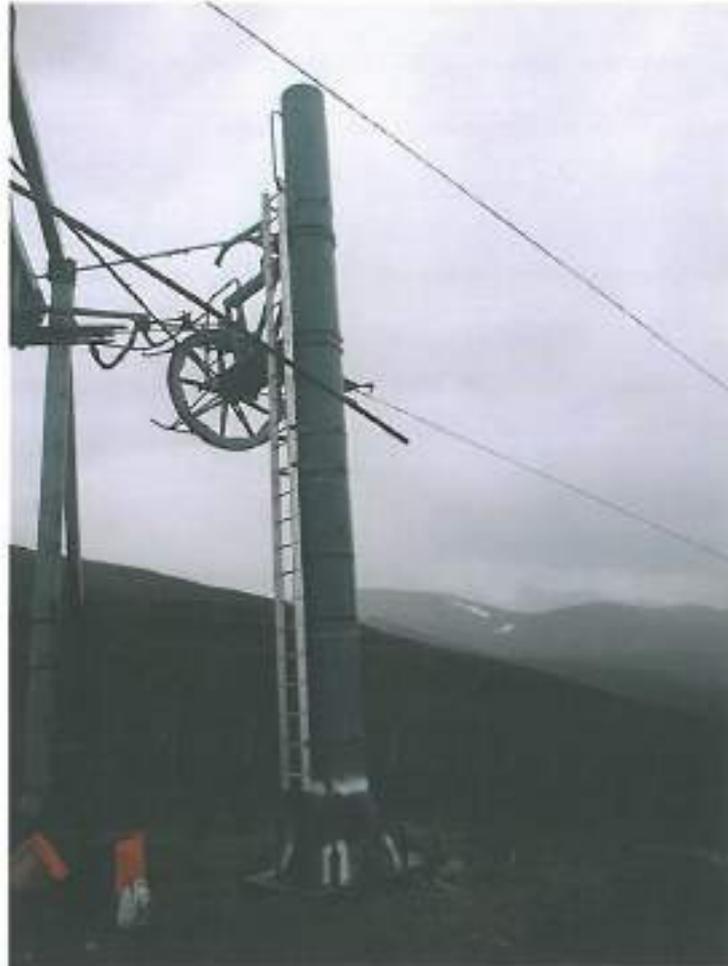
**Day Lodge Poma Tower 3**

T3	12 o/c	3 o/c	6 o/c	9 o/c
500mm	10.5	10.5	10.4	10.5
3000mm	5.6	5.7	5.5	5.4

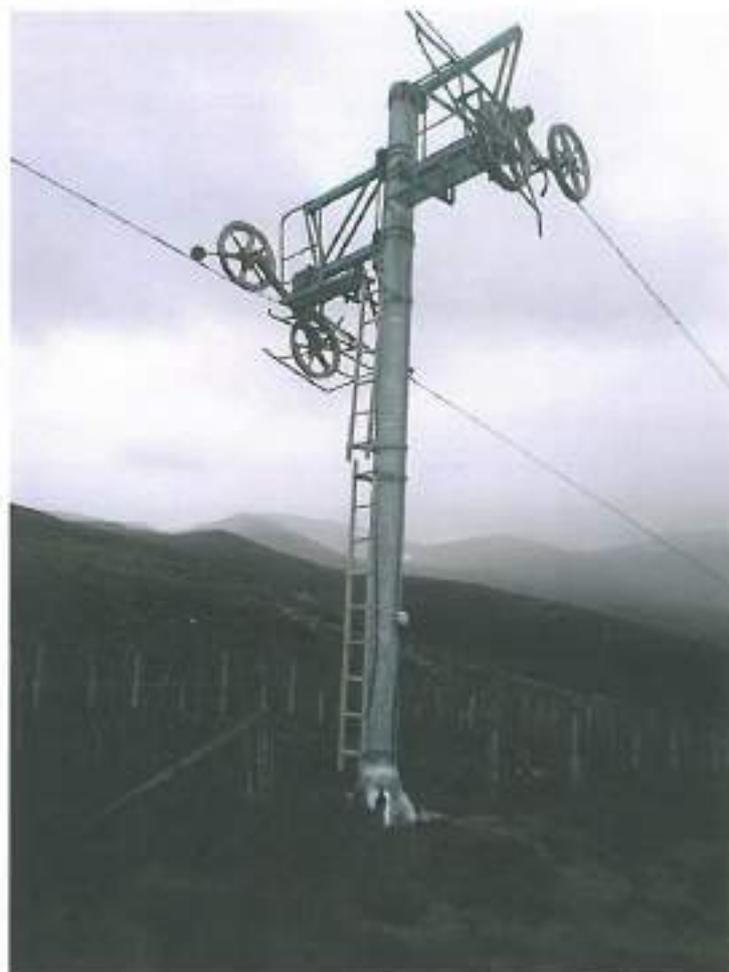
**Day Lodge Poma Tower 6**

<b>T6</b>	<b>12 o/c</b>	<b>3 o/c</b>	<b>6 o/c</b>	<b>9 o/c</b>
<b>500mm</b>	5.6	4.8	4.9	4.8
<b>3000mm</b>	4.8	4.7	4.7	4.8

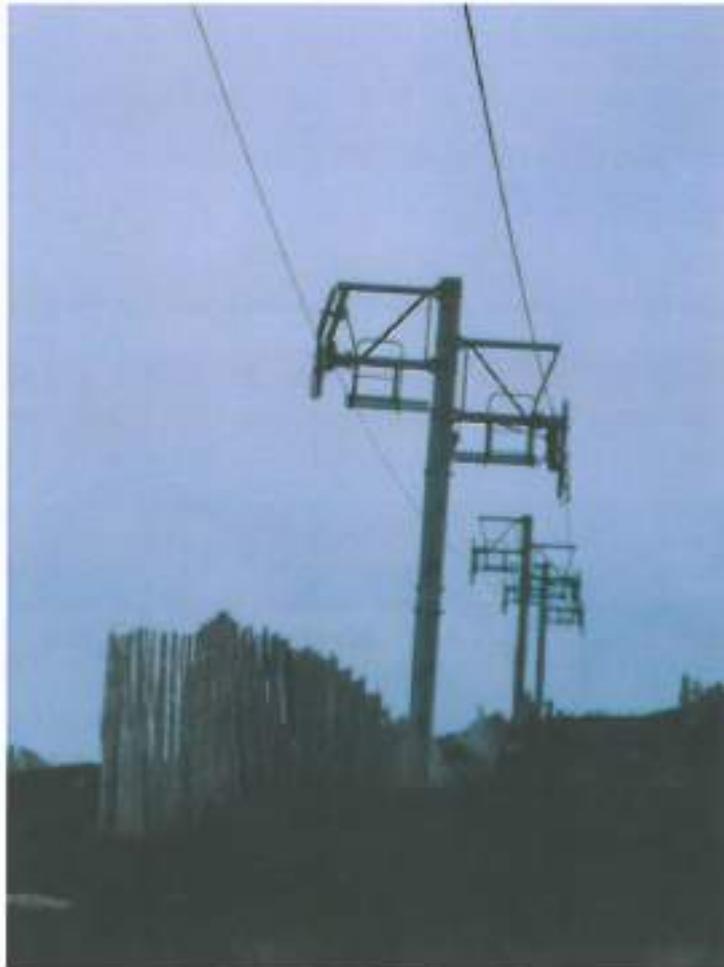
**Day Lodge Poma Tower 9**

T9	12 o/c	3 o/c	6 o/c	9 o/c
500mm	4.9	4.9	4.9	4.9
3000mm	4.6	4.6	4.6	4.8

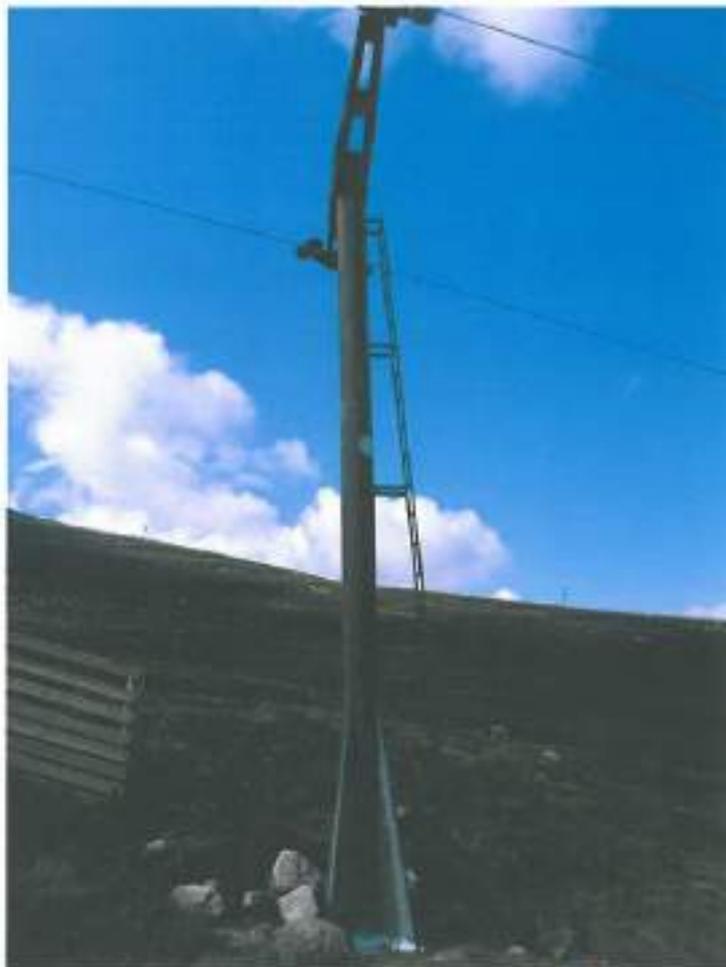
Car Park T-Bar Tower 2

T2	12 o/c	3 o/c	6 o/c	9 o/c
500mm	8.8	8.1	8.1	8.0
3000mm	7.5	7.1	7.2	7.3

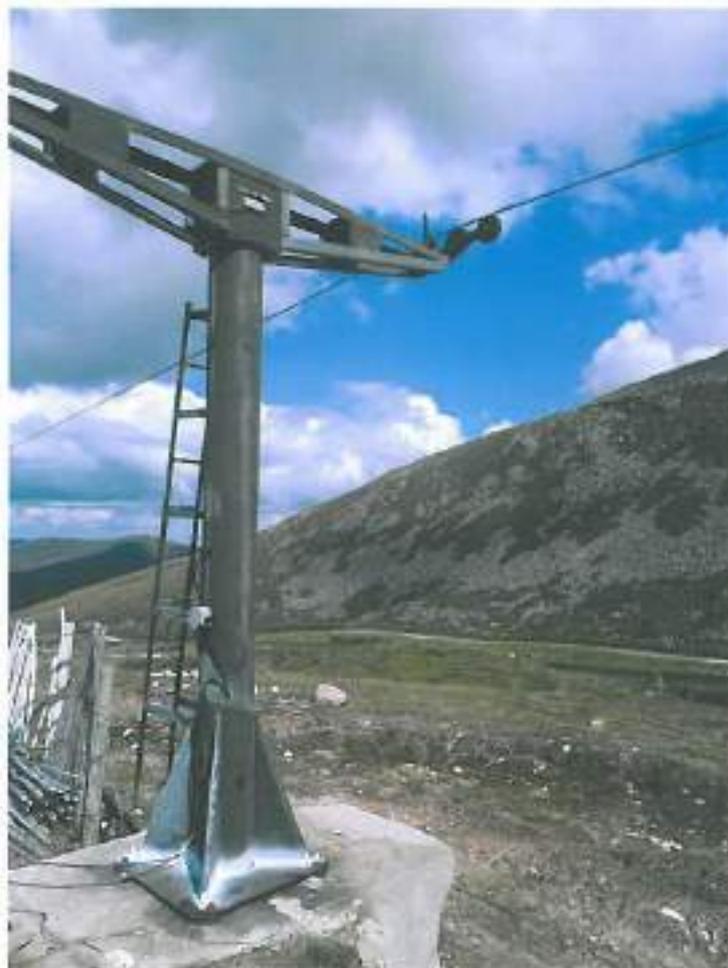
Car Park T-Bar Tower 6

T6	12 o/c	3 o/c	6 o/c	9 o/c
500mm	8.7	8.1	8.1	8.6
3000mm	8.6	8.4	8.7	7.9

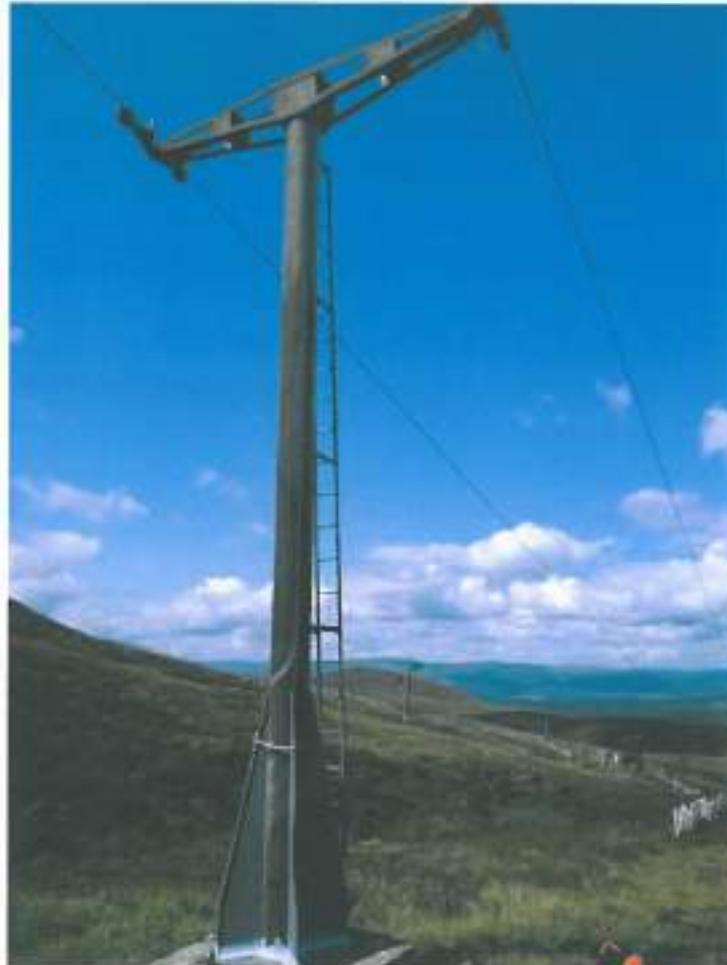
Car Park T-Bar Tower 11

T11	12 o/c	3 o/c	6 o/c	9 o/c
500mm	8.5	8.9	9.0	8.3
3000mm	7.9	8.9	8.8	8.2

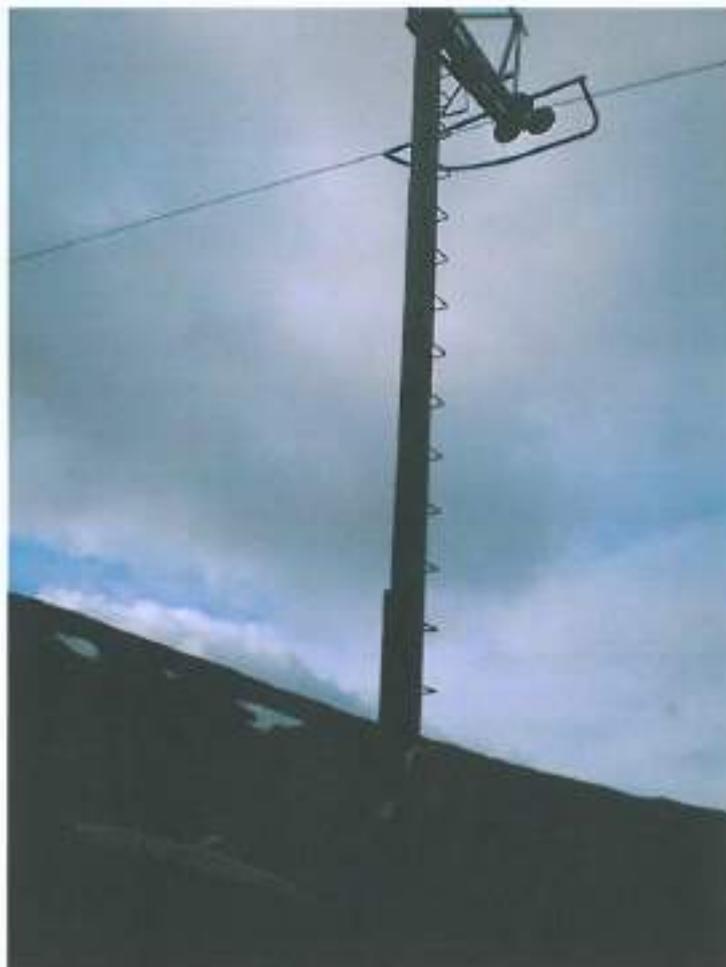
**Coire Cas T-Bar Tower A**

TA	12 o/c	3 o/c	6 o/c	9 o/c
500mm	7.7	8.5	8.5	8.5
3000mm	8.2	8.3	8.6	8.9

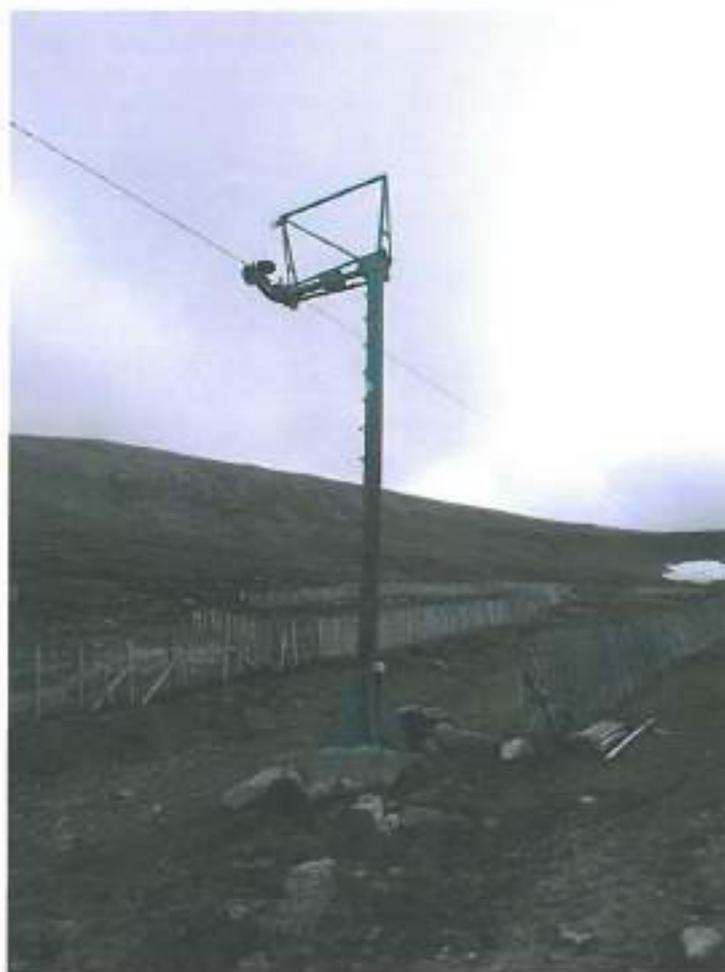
Coire Cas T-Bar Tower 2

T2	12 o/c	3 o/c	6 o/c	9 o/c
500mm	9.4	8.8	9.0	8.1
3000mm	9.3	8.8	9.5	8.4

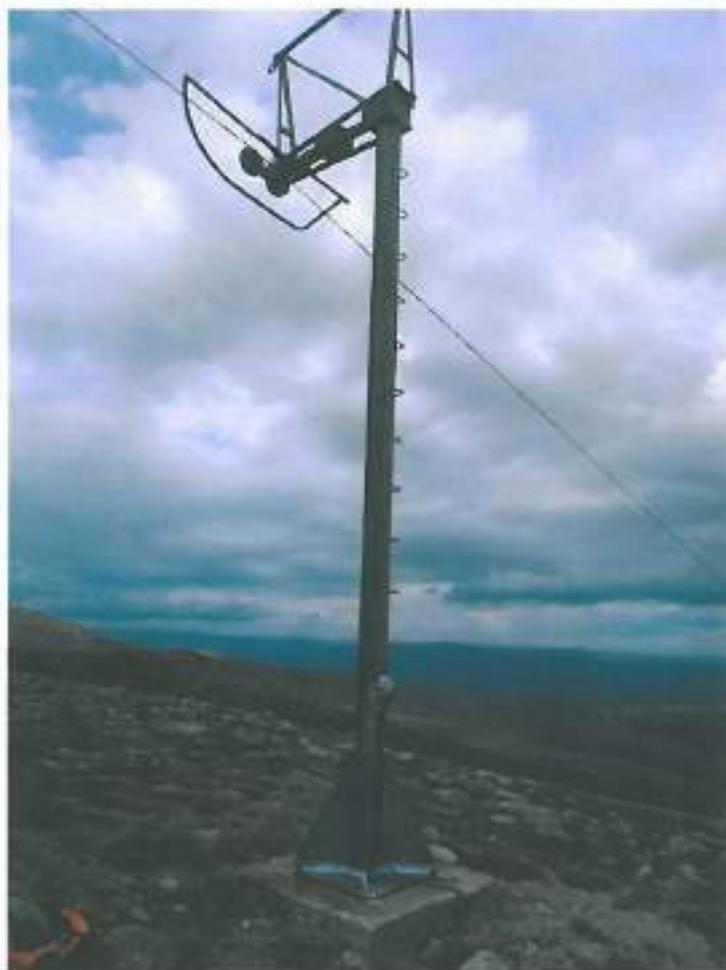
Coire Cas T-Bar Tower C

TC	12 o/c	3 o/c	6 o/c	9 o/c
500mm	7.7	7.6	7.7	7.8
3000mm	7.8	7.9	8.3	7.9

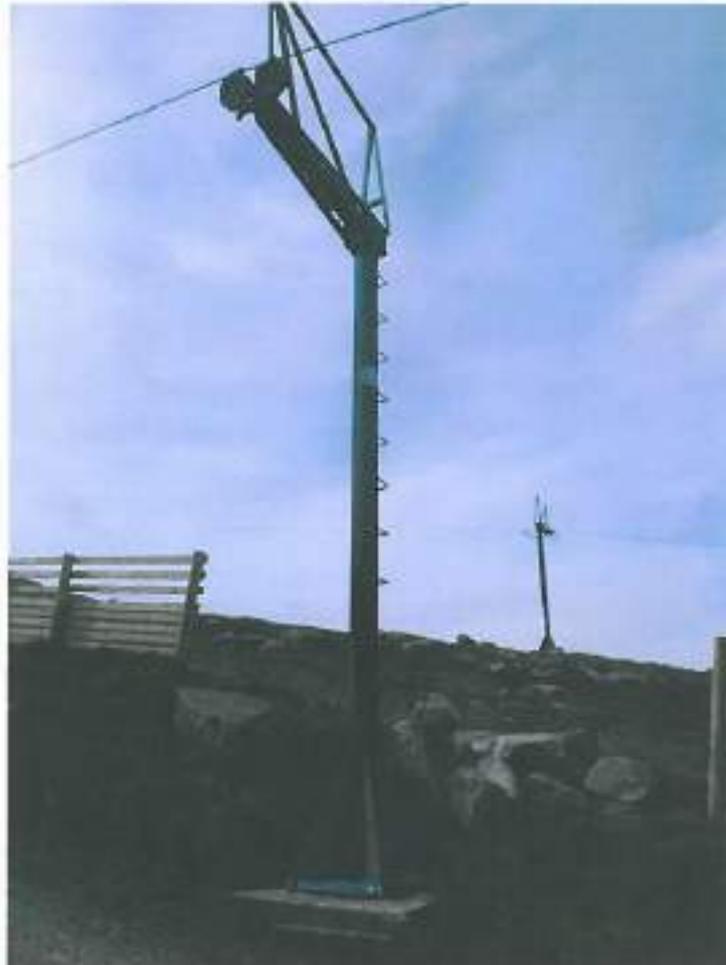
Coire Cas T-Bar Tower 5

T5	12 o/c	3 o/c	6 o/c	9 o/c
500mm	8.7	8.9	8.5	8.6
3000mm	7.7	8.4	7.8	7.8

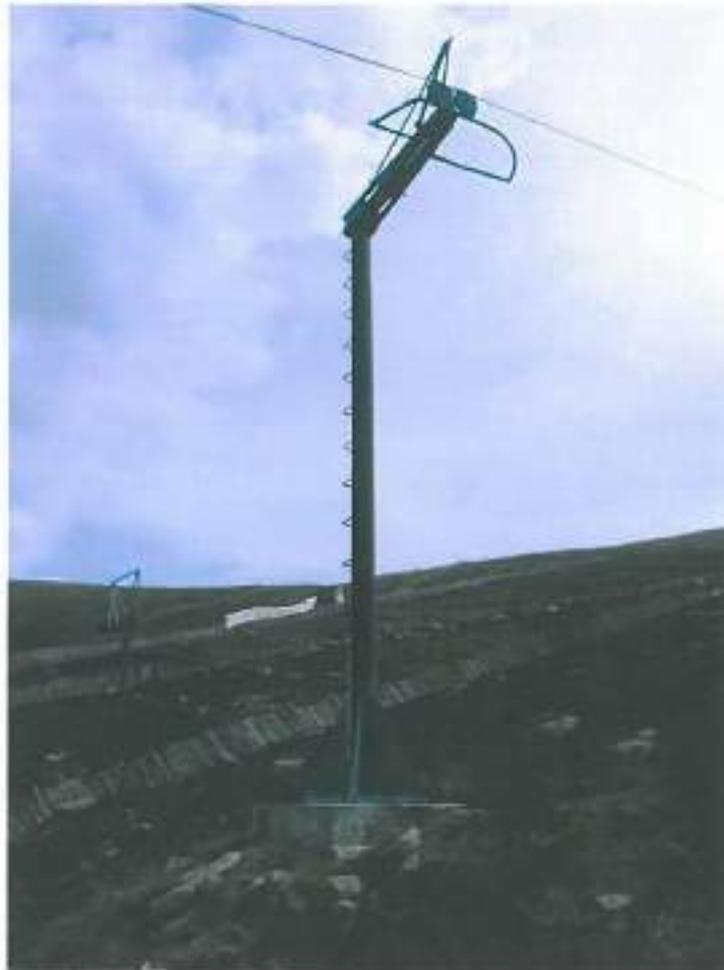
**Coire Cas T-Bar Tower E**

TE	12 o/c	3 o/c	6 o/c	9 o/c
500mm	8.0	8.8	8.8	9.0
3000mm	7.6	7.9	8.1	7.8

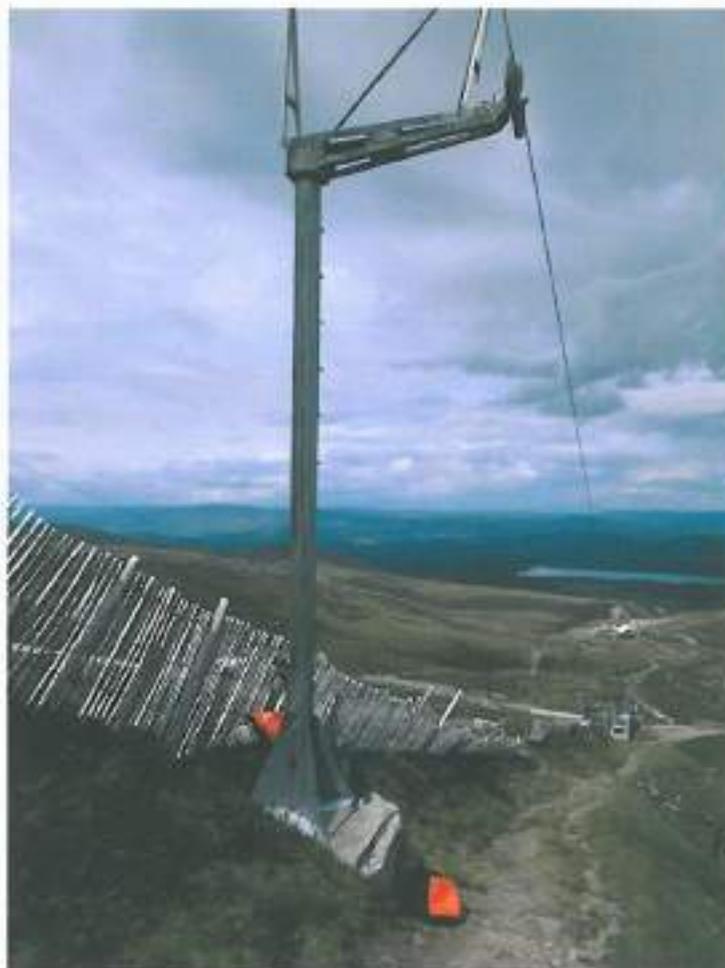
**Coire Cas T-Bar Tower 9**

<b>T9</b>	<b>12 o/c</b>	<b>3 o/c</b>	<b>6 o/c</b>	<b>9 o/c</b>
<b>500mm</b>	8.3	8.9	8.6	9.1
<b>3000mm</b>	8.5	8.3	8.5	8.4

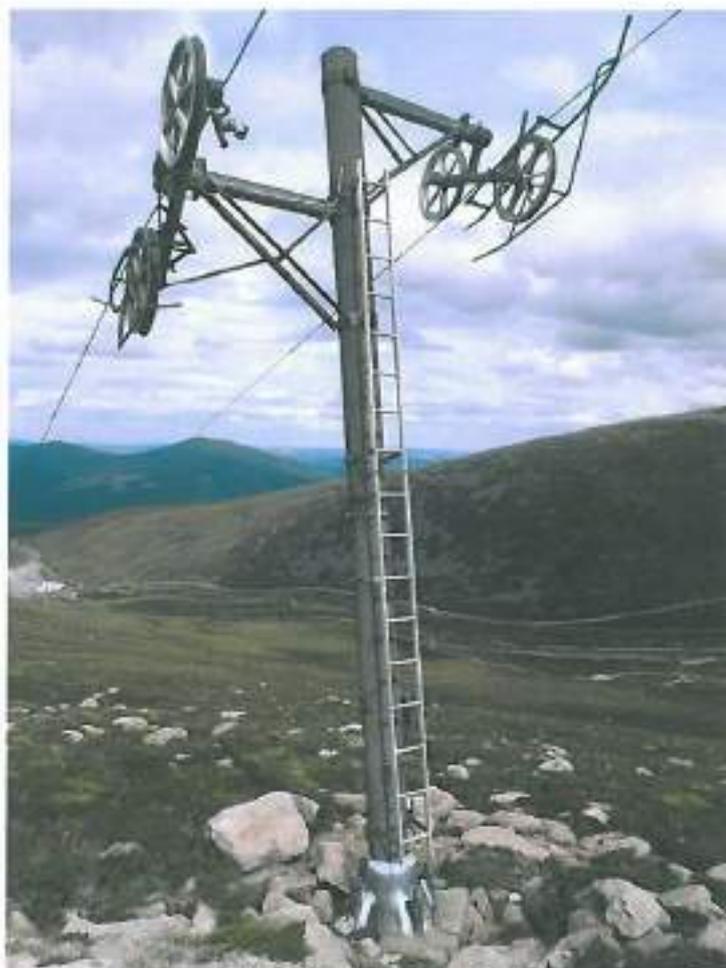
**Fiacaill Ridge Poma Tower 2**

T2	12 o/c	3 o/c	6 o/c	9 o/c
500mm	6.6	6.4	6.4	6.3
3000mm	6.5	6.3	6.6	6.5

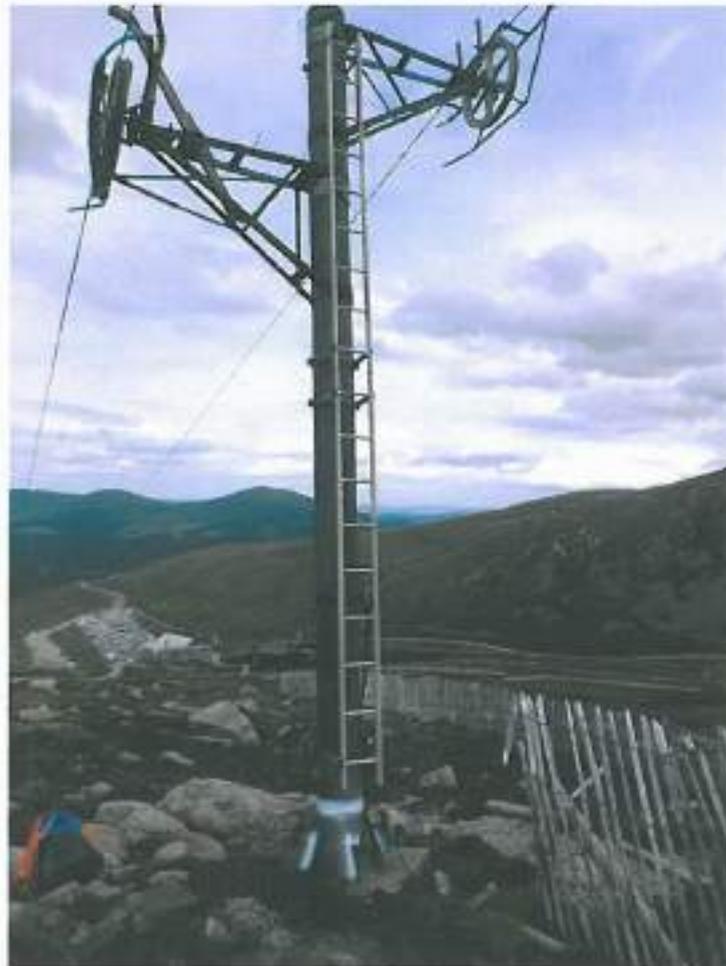
**Fiacail Ridge Poma Tower 6**

<b>T6</b>	<b>12 o/c</b>	<b>3 o/c</b>	<b>6 o/c</b>	<b>9 o/c</b>
<b>500mm</b>	9.8	9.6	9.9	9.8
<b>3000mm</b>	9.8	9.8	9.8	9.6

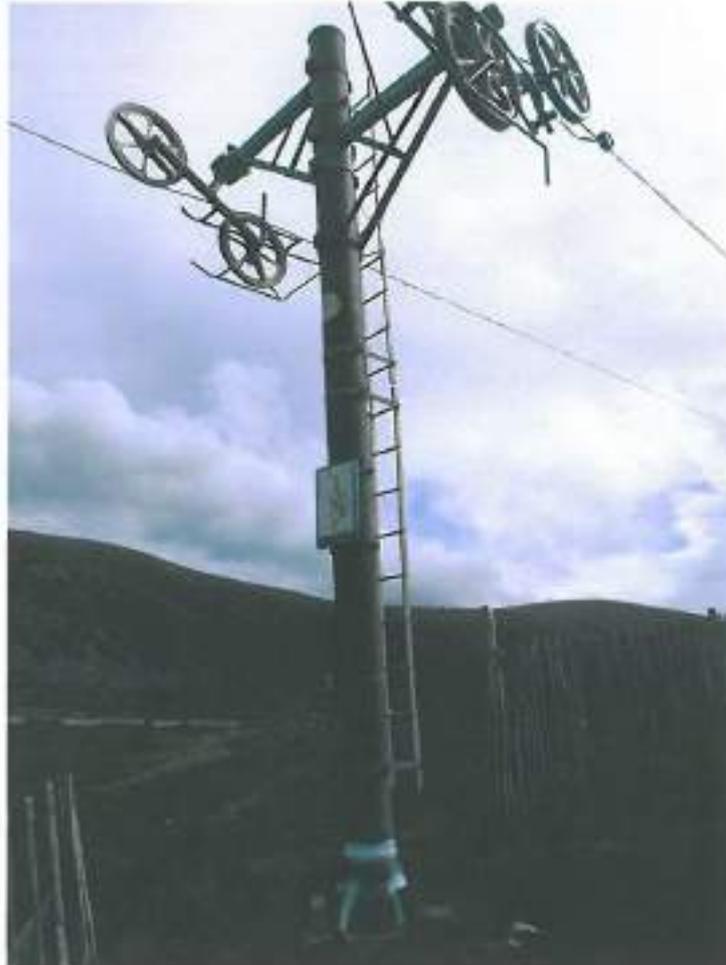
**Fiacall Ridge Poma Tower 9**

T9	12 o/c	3 o/c	6 o/c	9 o/c
500mm	9.1	9.2	9.4	9.4
3000mm	9.3	9.7	9.1	9.4

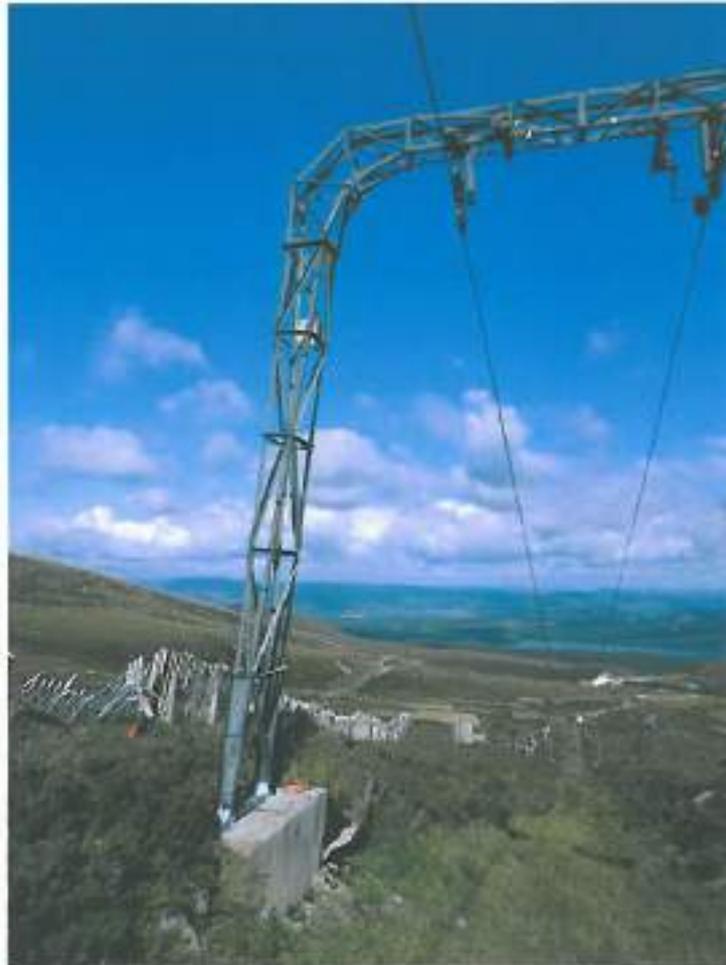
**Sheiling Platter Tower 1L**

<b>T1L</b>	<b>12 o/c</b>	<b>3 o/c</b>	<b>6 o/c</b>	<b>9 o/c</b>
<b>Base</b>	7.6	8.6	7.9	8.8
<b>500mm</b>	3.6	3.1	3.5	3.5

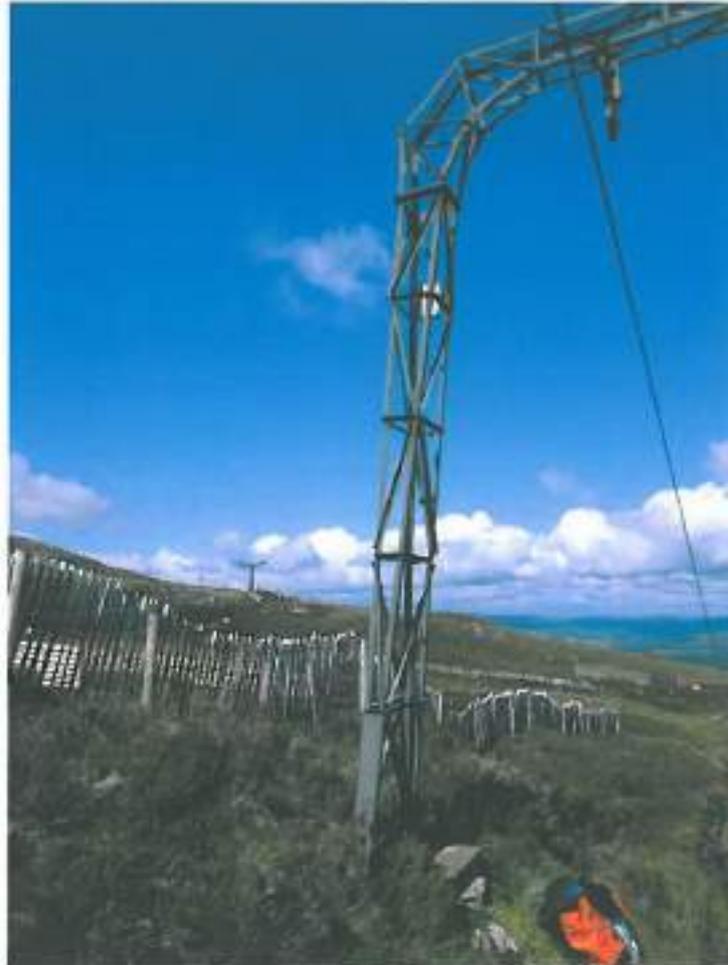
Sheiling Platter Tower 3L

T3L	12 o/c	3 o/c	6 o/c	9 o/c
Base	7.0	8.1	7.2	7.3
500mm	3.9	3.7	3.5	3.3

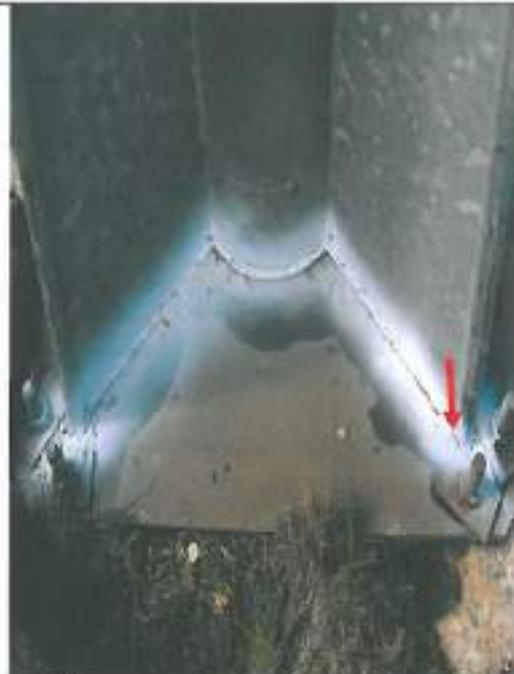
Photographic record showing Deck Plate and Stiffener welds with Anchor bolts on Tower 2.

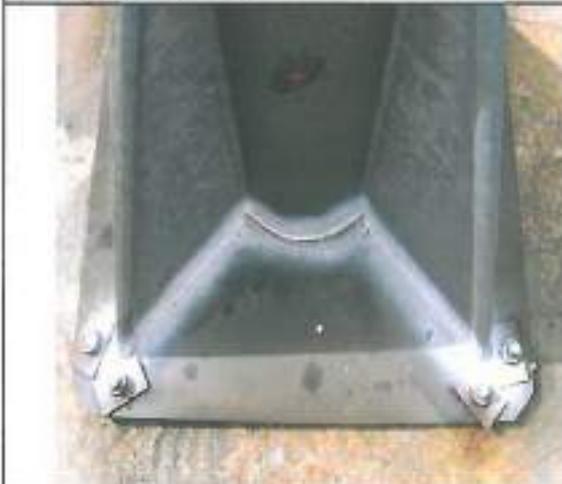
Photographic record showing 25% of inspection area of Base Plate Welds and Anchor Bolts and Washers on Tower 6.
