## Cairngorm Ski Towers Inspection Report

for Highlands & Islands

Job Ref: SJ1021

August 2014

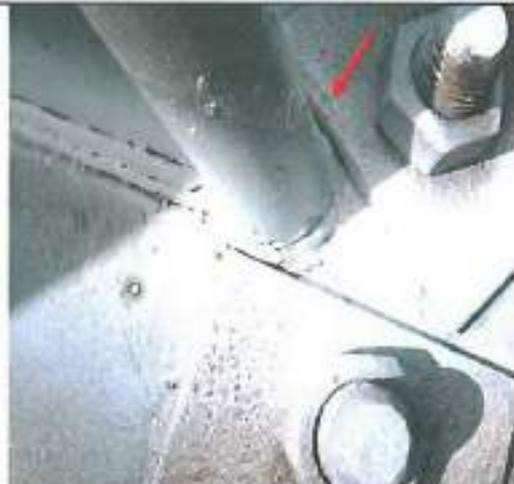
Further Photographic record showing Anchor Bolts and Washers restricting inspection of Weld Cap and HAZ on Tower 6.

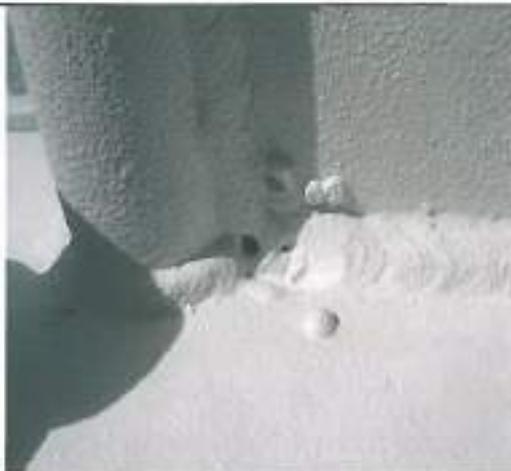
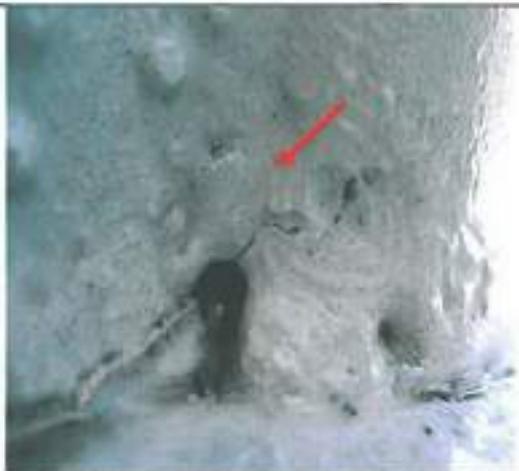
Tower 11: 3mm indication found on Right Hand side (facing up-hill) Stiffener Web. Porosity was also found on all 4 segments of Base Plate Welds. No Restrictions were encountered.

<p>Photographic Record showing Porosity on Stiffening Web facing up-hill (12 o'clock) on Tower 11.</p>	<p>Photographic Record showing Indication measuring 3mm and Porosity on Right Hand side (3 o'clock) Stiffener Web on Tower 11.</p>

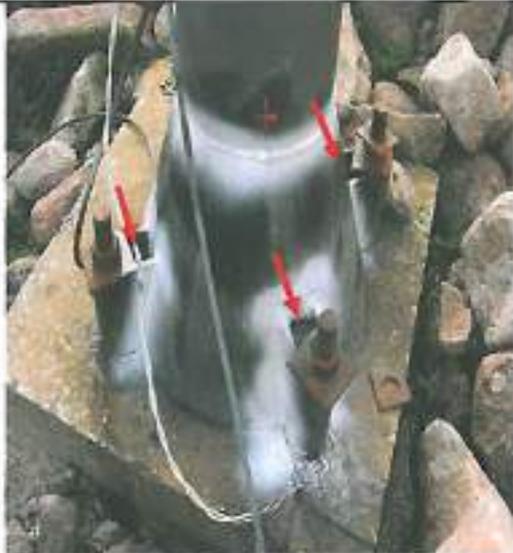
Tower 2: Restrictions were encountered where internal welds of Anchor Bolt Housings were inaccessible. No other restrictions were encountered. Porosity was found in the "Cone to Tower" weld at 6 o'clock (downhill).

Stand-off Photographic record of Base Plate Cone and Anchor Bolt Housings on tower 2. Restrictions encountered within housings indicated by red arrows.

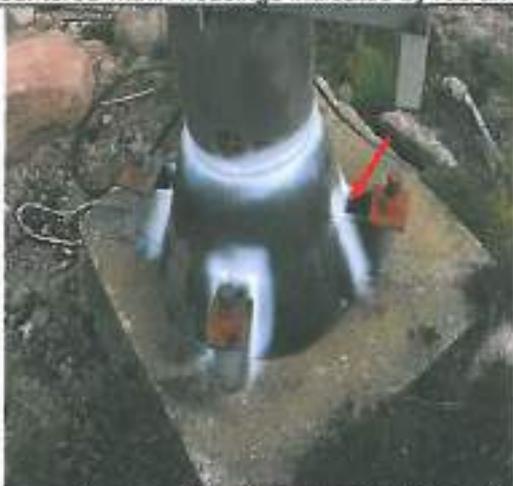
Tower 6: Restrictions were encountered where internal welds of Anchor Bolt Housings were inaccessible. No other restrictions were encountered. No Indications were found.

Photographic record showing extent of Magnetic Particle Inspection area at Base Plate Cone to Tower and Housing Welds and Anchor Bolts on Tower 6.

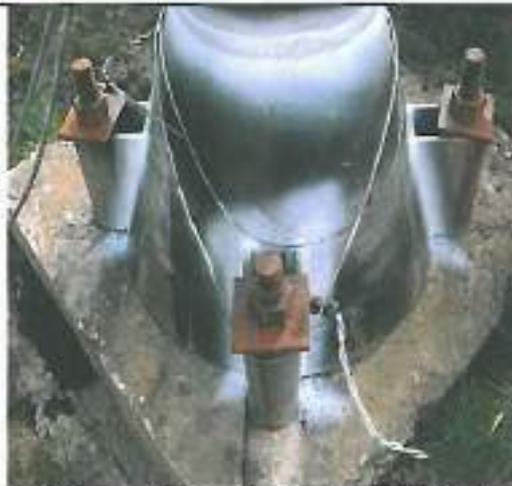
Tower 9: Restrictions were encountered where internal welds of Anchor Bolt Housings were inaccessible. No other restrictions were encountered. No Indications were found.

Photographic record showing Anchor Bolts/Washers and Cone to Tower Weld on Tower 9. High tensile wires are termination points for snow fences following the tow up the hill.

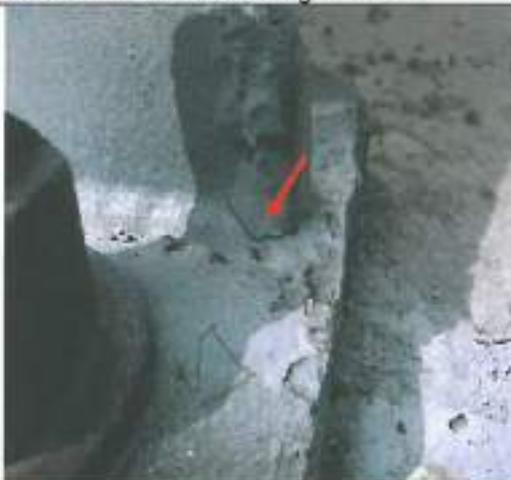
Tower 9: No restrictions were encountered. An 11mm Indication was found at the foot of the Stiffener web on the Left hand side looking up-hill.

Photographic record showing 11mm Indication at foot of Stiffener web on Left hand side up-hill Stiffener on Tower 9.

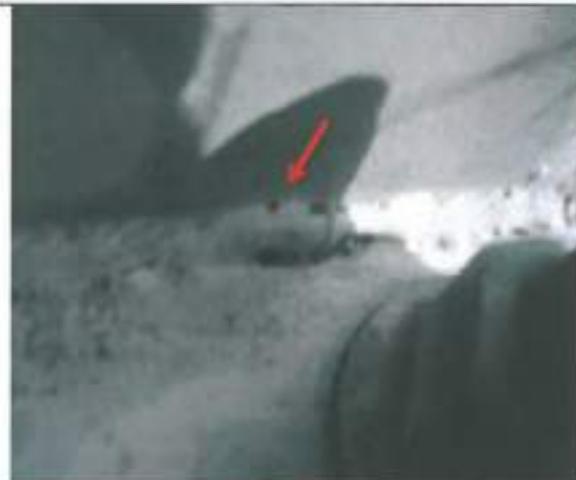
Photographic record showing Porosity on Stiffener Deck Connection weld on left hand side down-hill Stiffener on Tower 9.

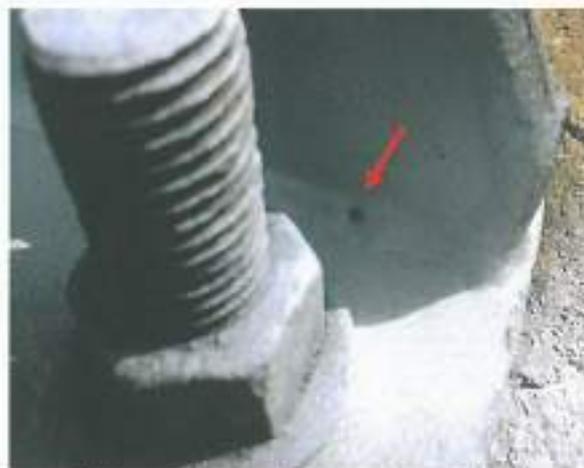
Tower E: No restrictions encountered. Undercutting was found on Tower to Deck Connection weld on Tower E facing down-hill. Porosity was also found on Stiffener Deck Connection weld on Right hand side Stiffener facing down-hill.

Photographic record showing Porosity on Stiffener Deck Connection weld on Right hand side down-hill Stiffener on Tower E.

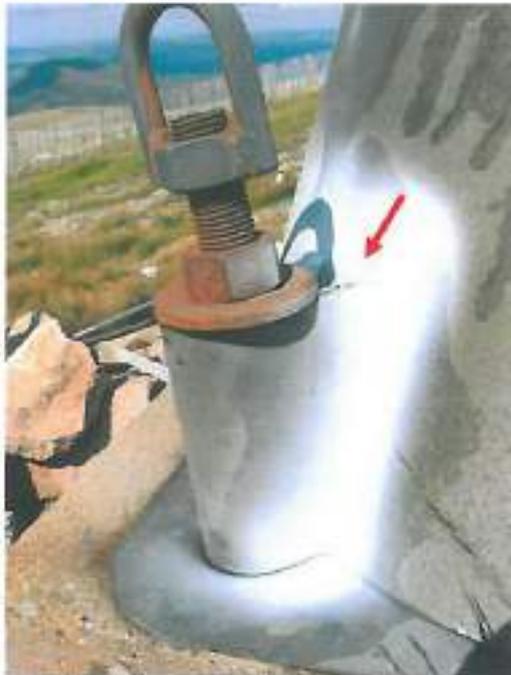
Tower 2: Restrictions were encountered to inspection on internals of Anchor Bolt Housings. No Indications Found.

Photographic record of Base Plate and Anchor Bolt Housing on Tower 2. Restrictions were encountered on internal Base Cone Connection from Anchor Bolt Housing.

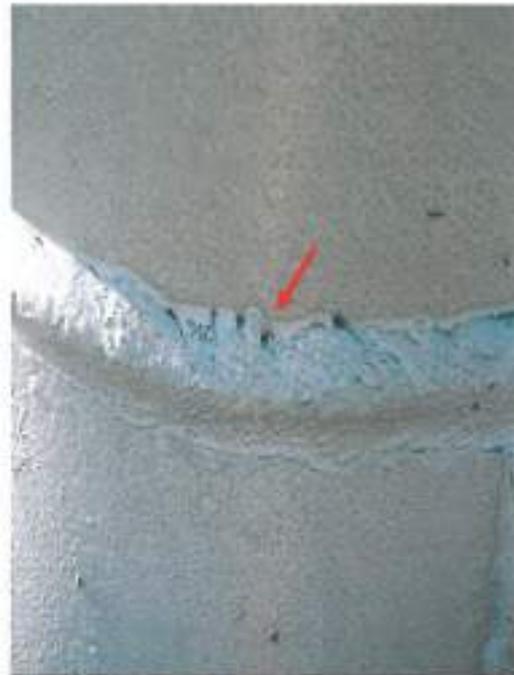
Tower 11: Restrictions were encountered to inspection on internals of Anchor Bolt Housings. Porosity was found on Anchor Bolt Housing weld on Left hand side facing down-hill. Undercutting was found on Left hand side (9 o'clock position). Porosity was also found on right hand side Cone to Tower Weld facing down-hill.

Photographic record showing Porosity on right hand side Cone to Tower Weld facing down-hill on Tower 11 indicated by red arrow.

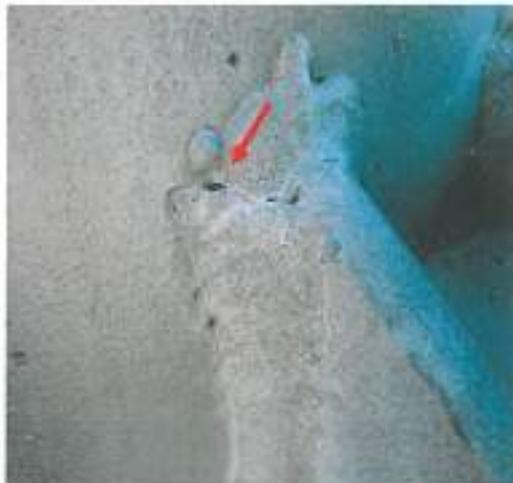
Photographic record showing Porosity on Anchor Bolt Housing weld on Left hand side down-hill facing on Tower 11.

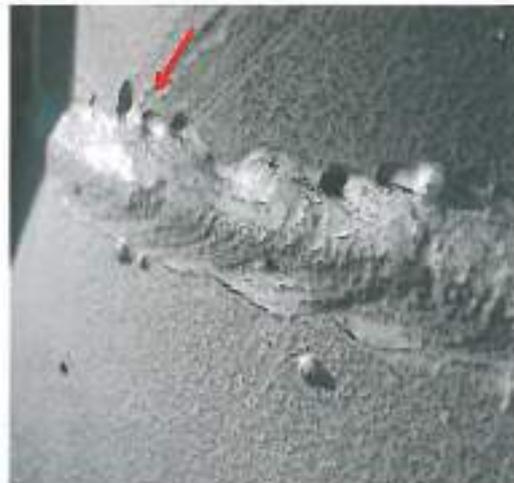
Photographic record showing Undercut on Left hand side (9 o'clock position) on tower 11.

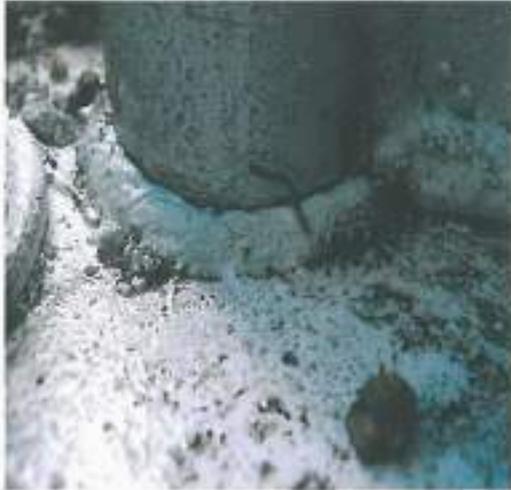
Photographic record showing 30mm indication on upward Stiffener Web Trim left hand side (Non Structural) on Tower 3.

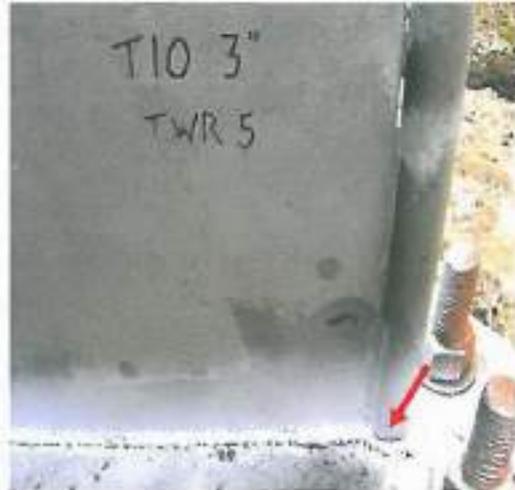
Photographic record showing 25mm indication on Web Stiffener Trim on Tower 5 at 3 o'clock Position (looking up hill). Indication does not affect structural integrity of Stiffening Web.

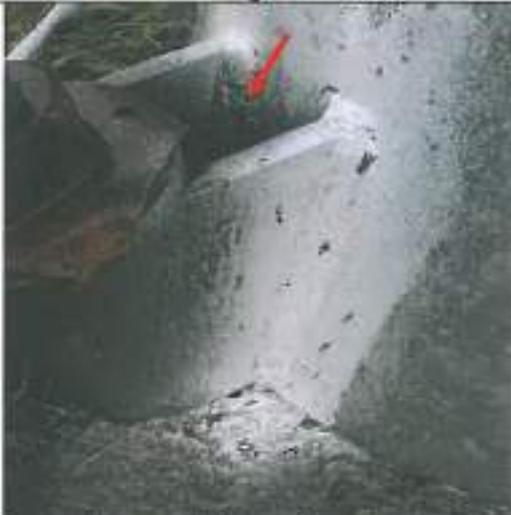
Photographic record of Base Plate Cone and Anchor Bolts and Housing on Tower 15. Arrow indicates restricted access to internal Anchor Bolt Housing.

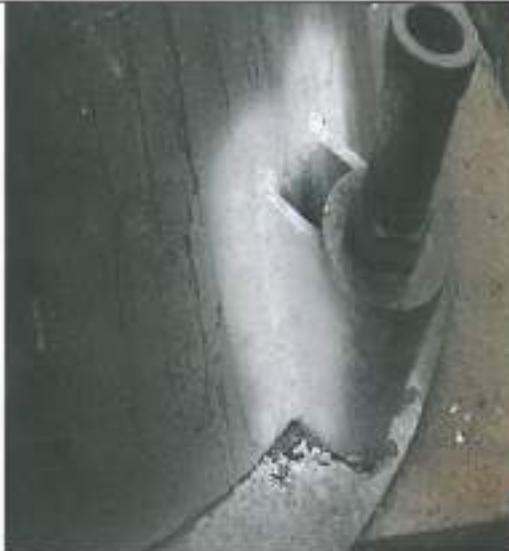
Tower 3: No Indications Found. Restrictions encountered on internal Anchor Bolt Housing.

Photographic record of Base Plate and Anchor Bolt Housing on Tower 3. Restrictions encountered on internal Anchor Bolt Housing.

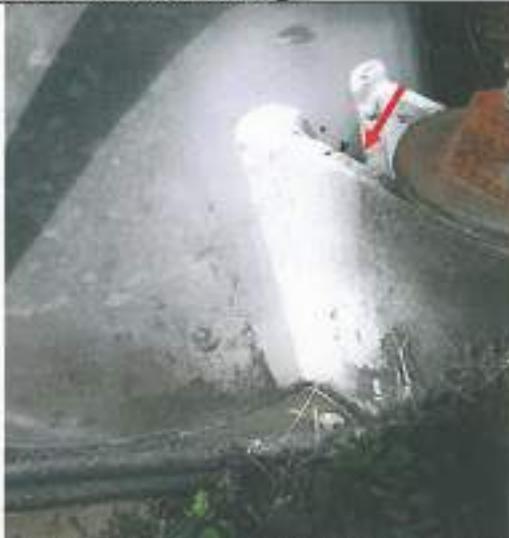
Photographic record showing Anchor Bolt Housing and internal Restricted Inspection area on Tower 8.

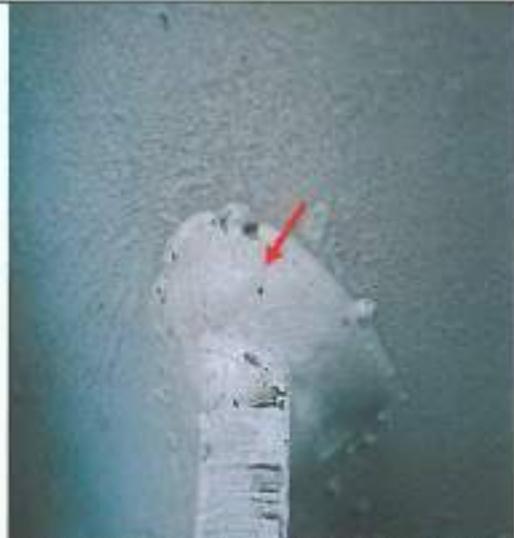
Photographic record showing Porosity at 10 o'clock Anchor Bolt Housing facing up hill on Tower 9.
